# Causeway Lake Dredging - Engineering Feasibility Evaluation

Reference: R.A10946.002.02.DredgingFeasibility.docx  
Date: September 2021  
Confidential

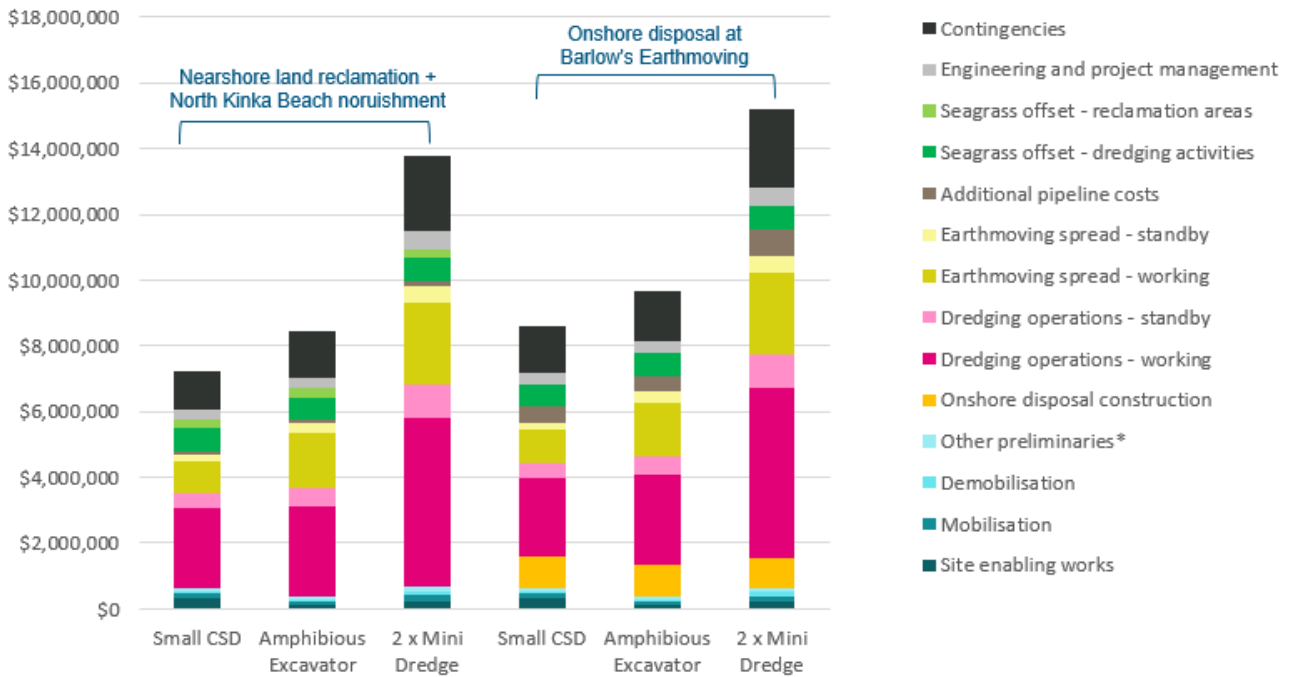
A Rough Order of Magnitude Cost Estimate (ROM Estimate) was developed for six feasible dredging scenarios, following a bottom-up approach with inputs from typical industry rates and analogous/comparative values from past BMT projects. The ROM Estimates are illustrated in Figure 2 and were broadly categorised into four streams: preliminaries, costs associated with dredging activities, costs associated with the transportation and placement of dredged material, and costs associated with environmental offsets. The small CSD was assessed as the most cost-effective option and is also the most efficient option (estimated completion within one year). Higher costs and longer durations are associated with the amphibious excavator and mini dredge options. The potential environmental impacts associated with each scenario vary, but not significantly.

Figure 2 ROM Estimate for Six Dredging Scenarios (\$AUD in 2021)

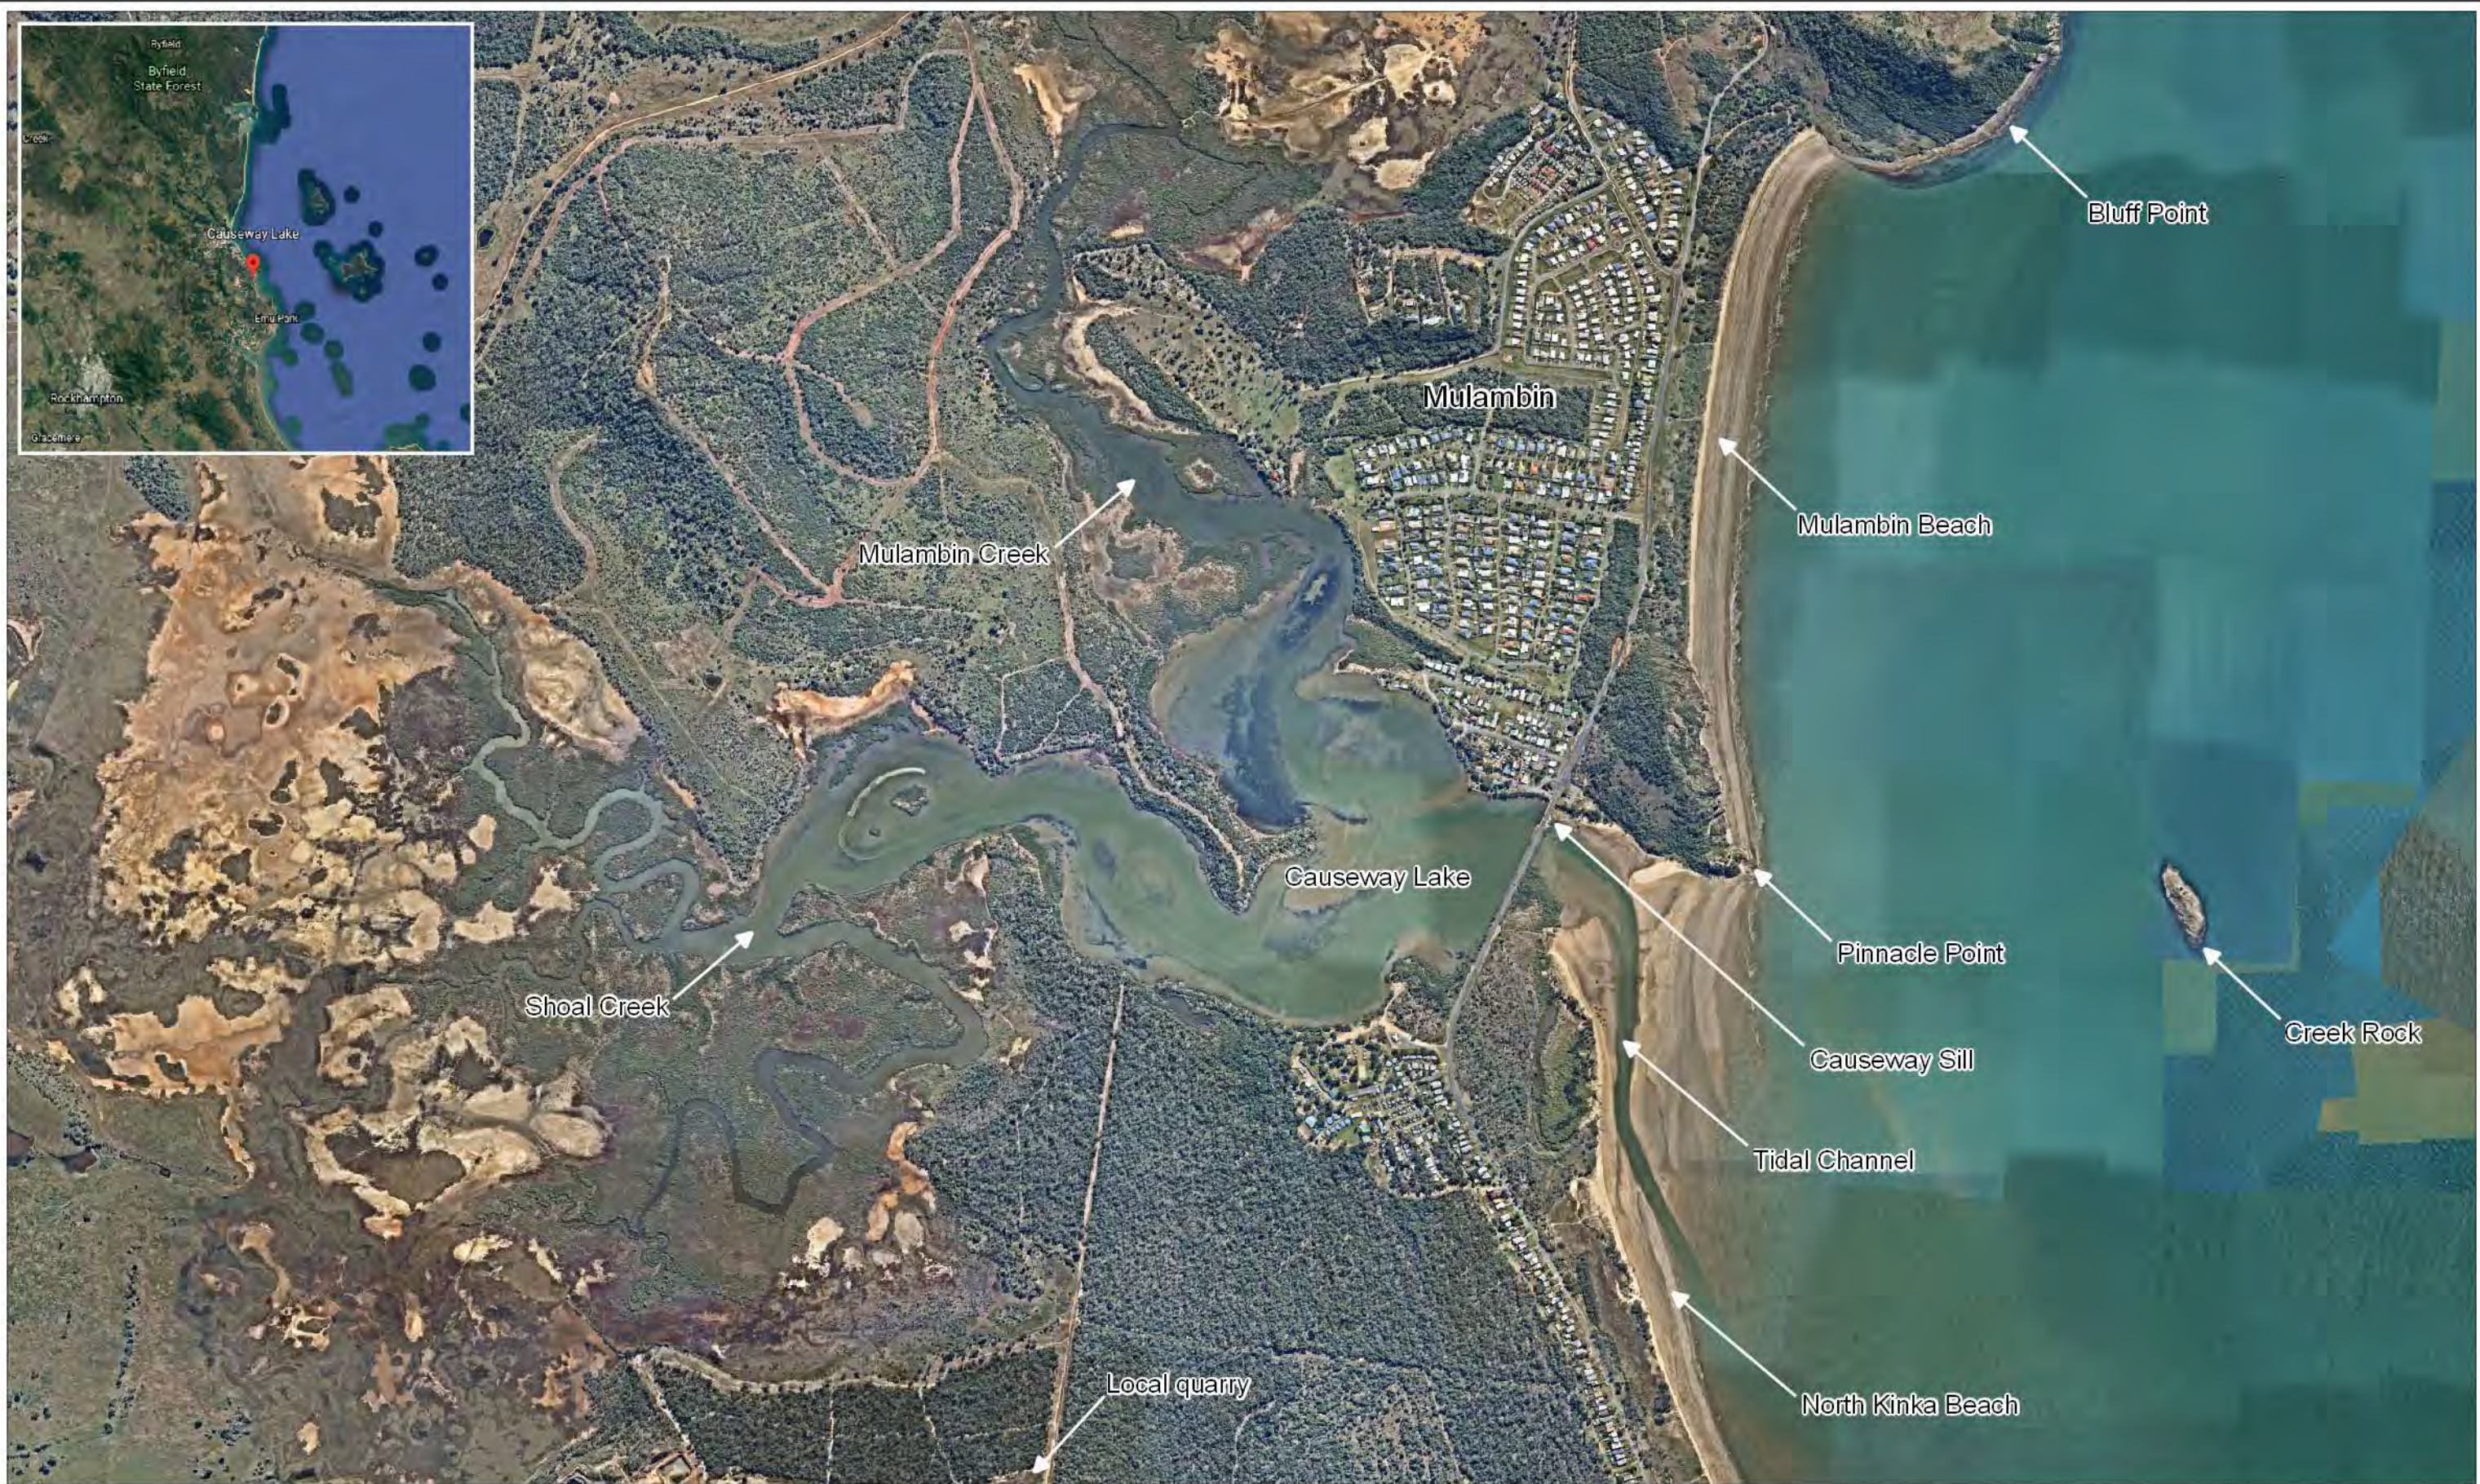
Figure: **1-1** Rev: **A**

Title:  
**Study Area**

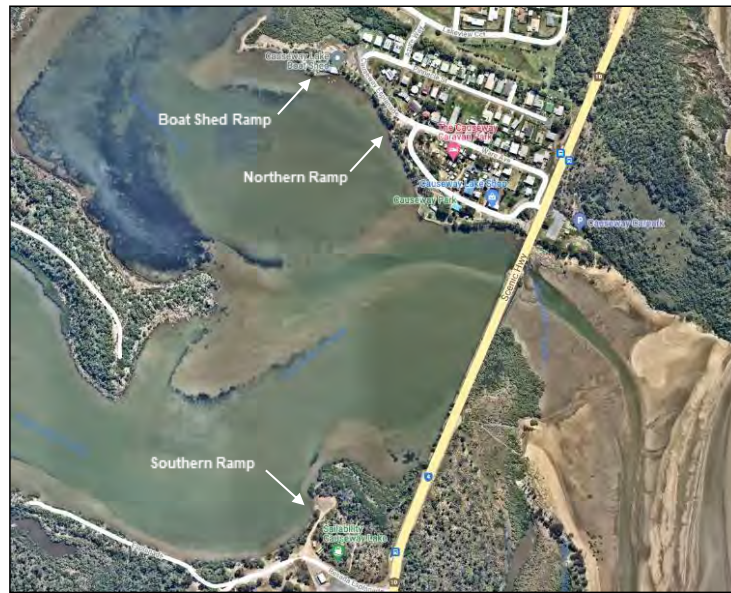
Currently, the Lake has no navigational access to the ocean. Small motorboats and other water sports access the Lake from three internal boat ramps: two on the northern shore and one on the southern shore (Figure 3-1). All three boat ramps are situated on minor roads surrounding the Lake. The capacity of these ramps with respect to launching dredging equipment is briefly discussed below and considered further in Section 6.

Figure 3-1 Existing boat ramps within Causeway Lake

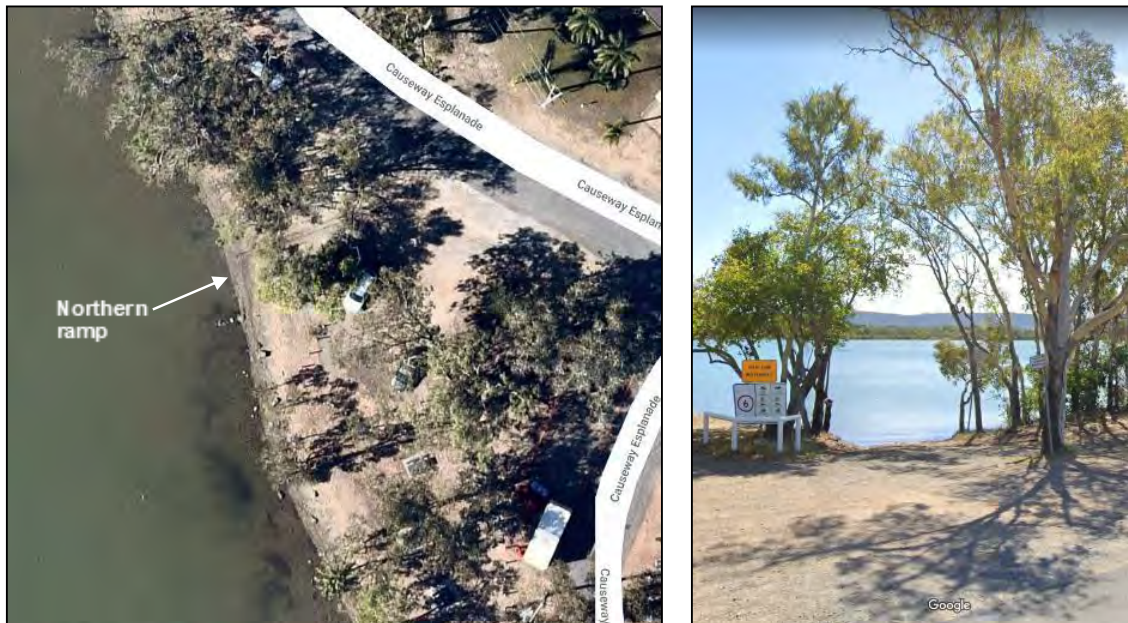
The northern boat ramp is a small, natural surface ramp extending off Causeway Esplanade, a paved residential street. There is an unpaved parking lot adjacent to the boat ramp, measuring approximately 12 x 25 m. Several trees line the ramp and the approach, restricting the width and height of the ramp space. Clear dimensions for the ramp are unknown, however, it's likely to be comparable or smaller than the concrete southern ramp.

Figure 3-3 Northern boat ramp. Left: December 2020 aerial image of the boat ramp, Right: street view of the boat ramp, from Causeway Esplanade

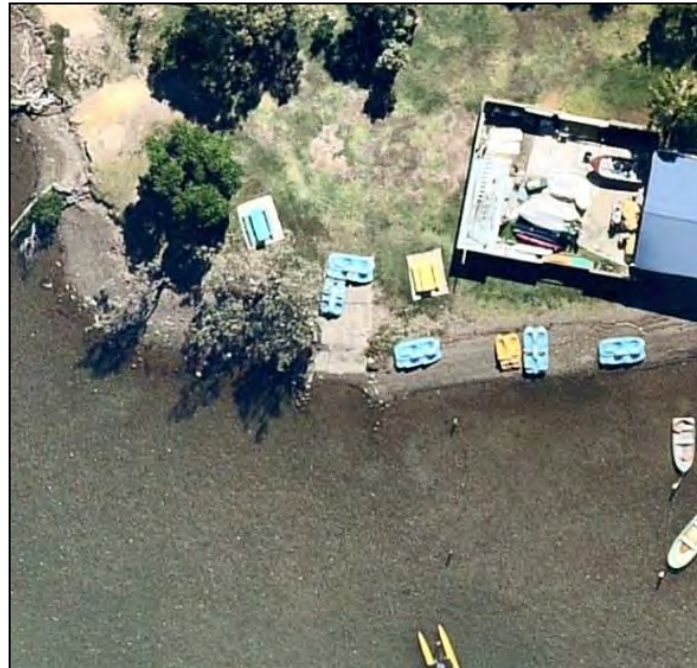
The concrete slab west of the Boat Shed is ~3.5 m wide. From available aerial imagery, it appears this slab doesn't extend into the water. There is a gate restricting access from Causeway Esplanade, and the grass meadow behind the slab indicates infrequent use. These factors, combined with the proximity to the Boat Shed, suggest this ramp is private use only. The ramp is unlikely to have been constructed to any design guidelines and is expected to be unsuitable for launching any dredges.

Figure 3-4 Boat Shed Ramp

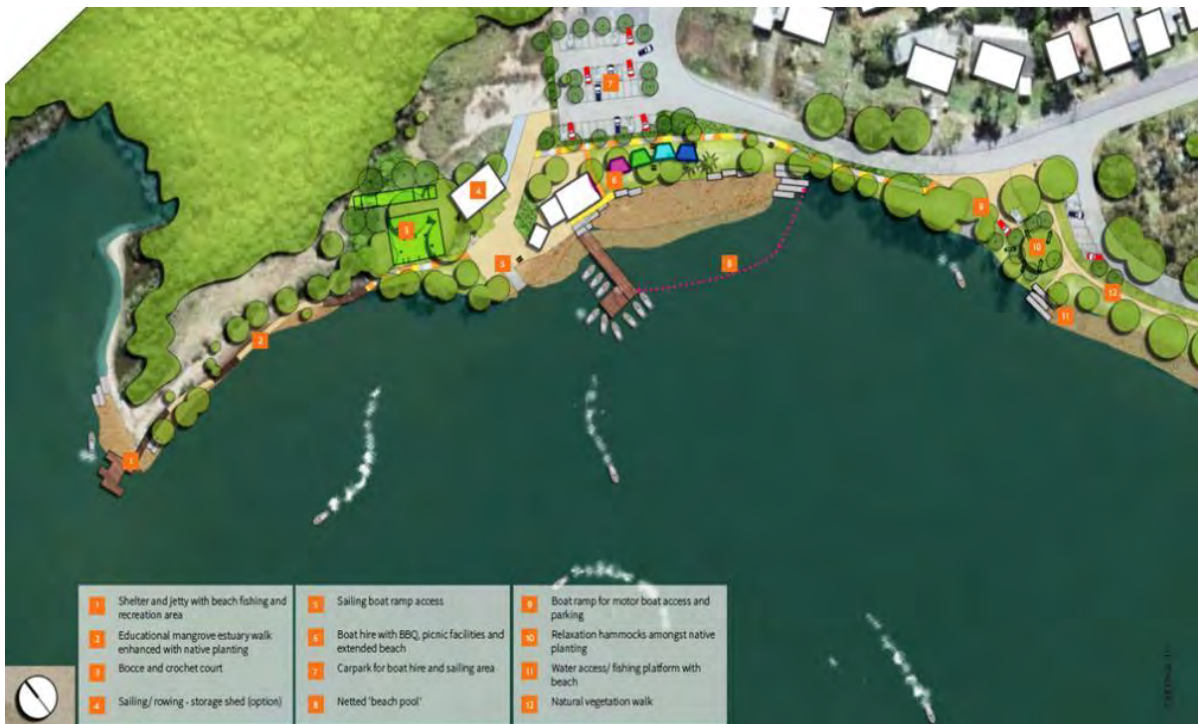
Figure 3-5 Northshore West – Concept (Active Living Landscapes 2016)

- Redevelopment of the “North Shore” including parking, active transport networks, jetties, hire kiosk, swimming beach, picnic facilities, water access and public boat ramp (Figure 3-5, Figure 3-6).
- Redevelopment of the “South Shore” including parking, active transport networks, jetties, public boat ramp, club facilities for Sailability and Sailing, kiosk, beachfront, swimming pontoons and picnic facilities (Figure 3-7).

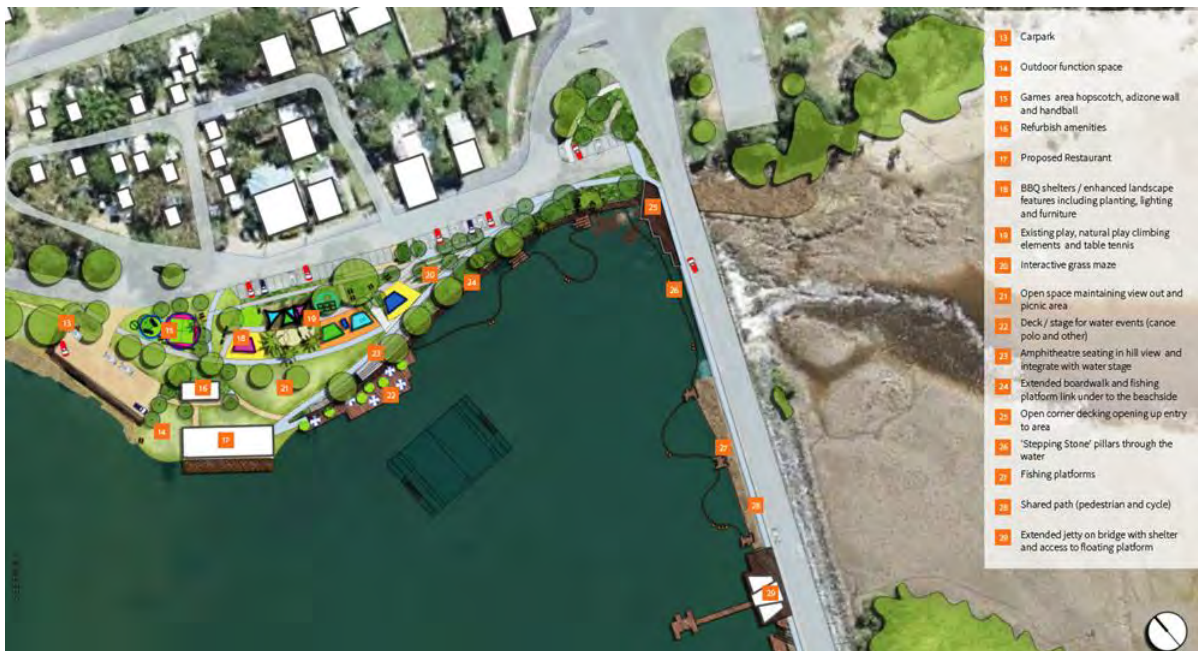
Figure 3-6 Northshore East – Concept (Active Living Landscapes 2016)

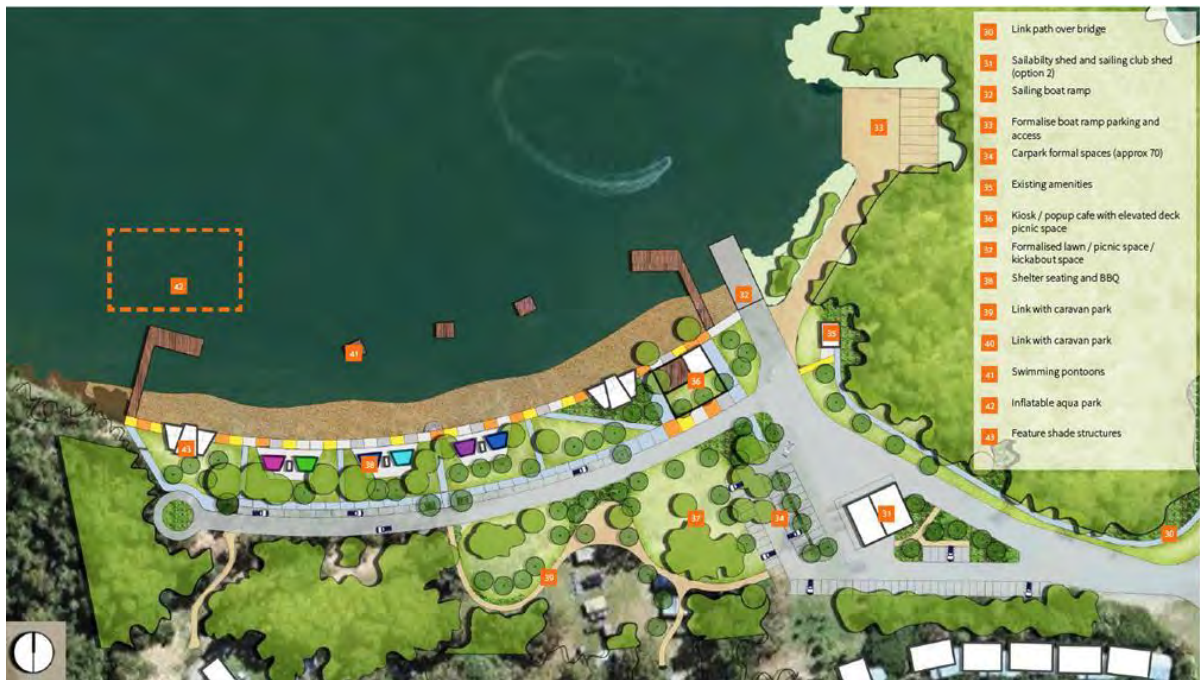
Figure 3-7 Southshore Concept (Active Living Landscapes 2016)

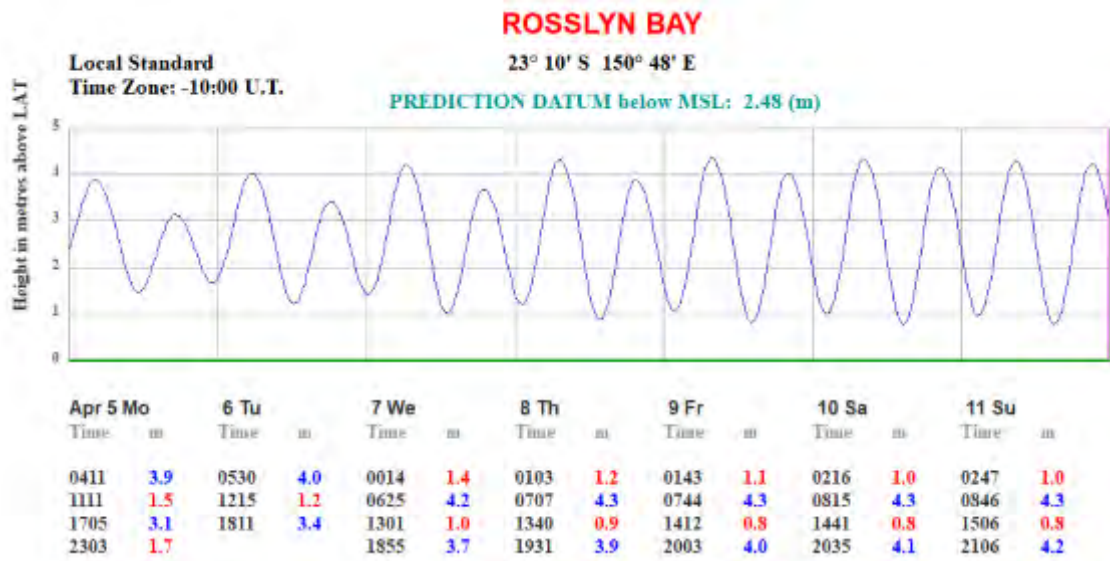
Tidal exchange within the lake occurs during periods of larger amplitude spring tides and is then restricted during periods of smaller amplitude neap tides. The ‘open’ or ‘closed’ tidal condition within the lake alternates approximately weekly. The published tidal planes for the Rosslyn Bay standard port location are provided in Table 4-1 and astronomic tide prediction over the site investigation period is indicated in Figure 4-1.

Figure 4-1 Rosslyn Bay Astronomic Tide Prediction: Site Investigation Period 9-11 April 2021 (Australian Hydrographic Office 2021)

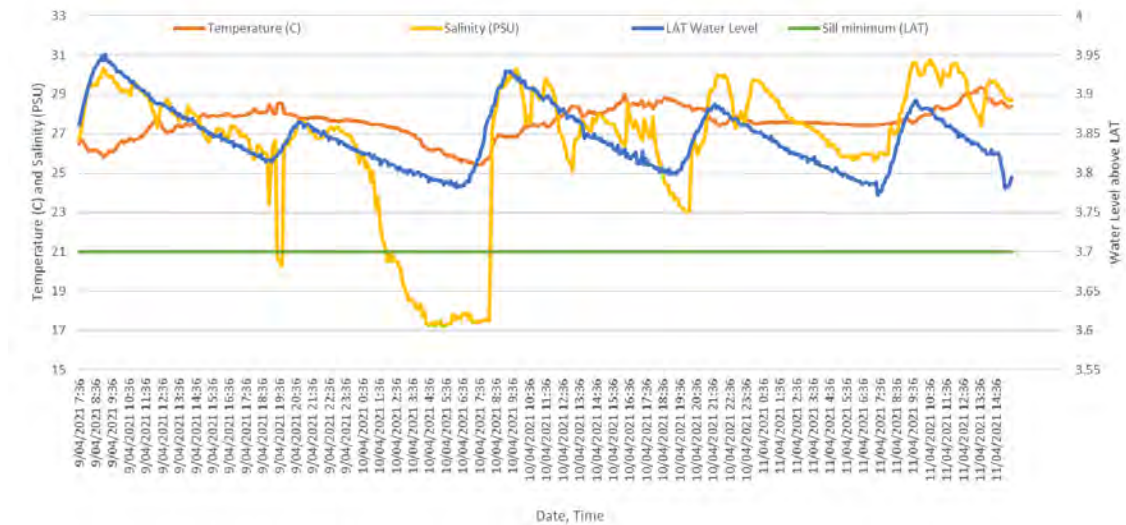
The salinity signal was highly variable and probably reflected carry-over freshwater from preceding rainfall mixing with saline ocean water. Peaks in salinity occurred at the top of the incoming tidal signal with sharp reductions and increases in salinity occurring at the onset of the incoming tide. This may be the result of eddying around the shallower bathymetry south of the boat hire building. Temperature appeared less affected by tides and followed diel pattern (warmer in the day) more closely.

Figure 4-2 Water level, salinity and temperature observations

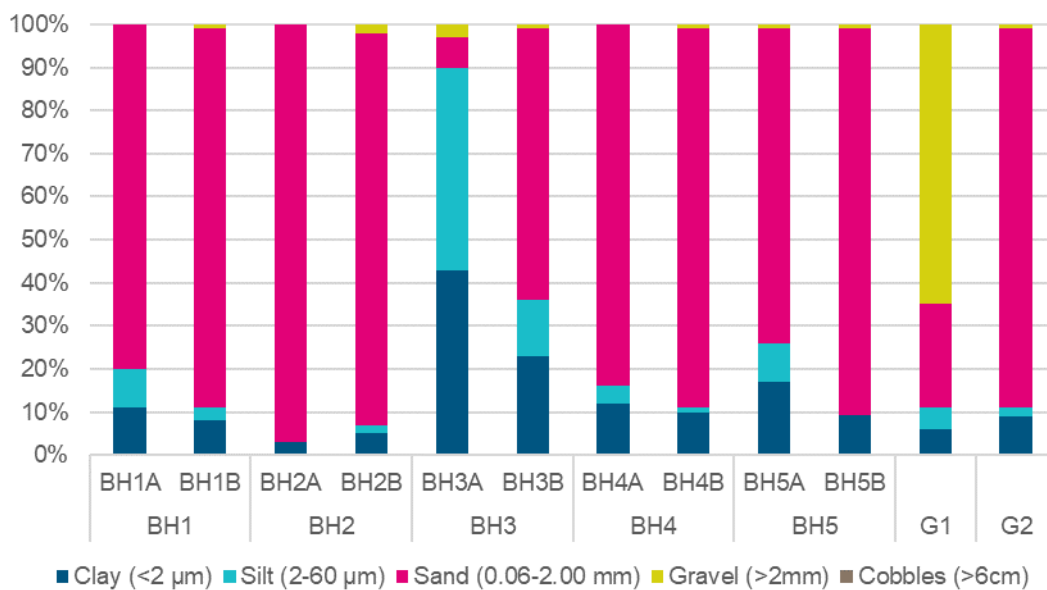
A summary of the laboratory results of the particle size distribution (PSD) analysis is shown in Figure 4-4. BH3 had a deep layer of fines, dark grey mud was present from 4-60 cm below lakebed, followed by a sandy mud layer from 60-110 cm, before giving way to muddy sand from 110-118 cm. This very abrupt change in sediment may coincide with sedimentation over the top the original sandy estuarine bed prior to the construction of the causeway. The correlation between BH3 and BH5 suggests that the lakebed surface material on the western side of the Lake, between the southern boat ramp and that of the Shoal Creek, tends to be on the finer side compared to the rest of Lake.

Figure 4-4 Particle size distributions for major grain-size fractions at each sample location

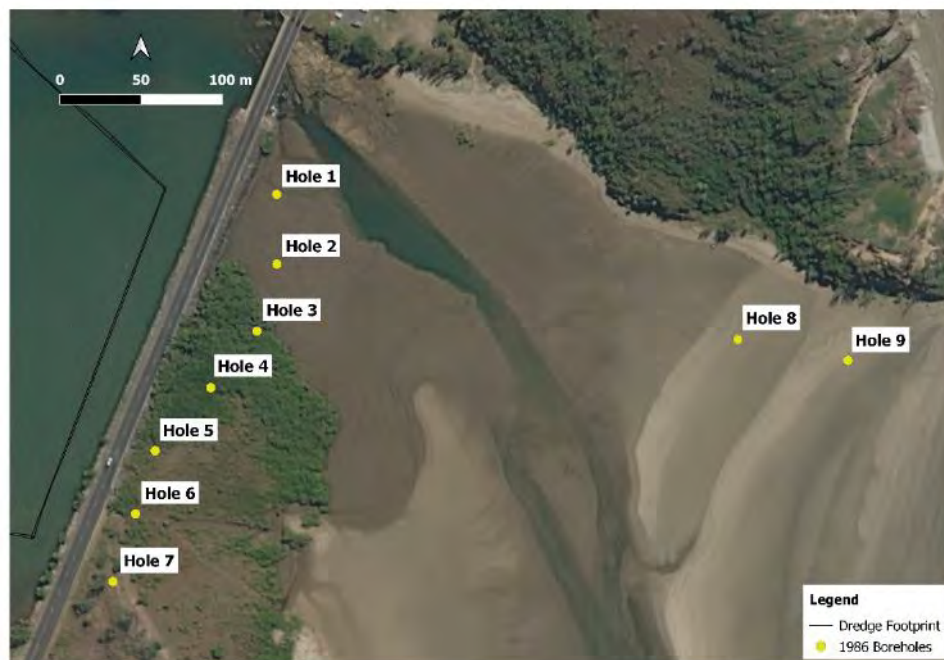
The former Main Road Department undertook sediment sampling in December 1987 for the Causeway Lake Bridge Site Foundation Investigation. The boreholes depths are referenced from AHD, however, the horizontal datum is not clearly defined. The borehole locations are referenced from the centreline of the road, measured from the southern abutment of the bridge, and all boreholes are located 'left of the centreline' to the direction of chainage (north to south). Figure 4-6 shows the assumed locations based on BMT's interpretation of the reporting.

The samples extended to depths well in excess of the BMT sampling in 2021, and provide valuable insight into the presence of consolidated material. The upper sediment horizons are predominantly described as silty sand, being fine grained and very loose. In some samples, this silty sand layer extends the entire sample length, whereas in other cases the sediment transitions to a consolidated argillite layer at approximately -5.5 m to -8.0 m AHD (Main Road Department 1987).

Figure 4-6 1987 borehole location

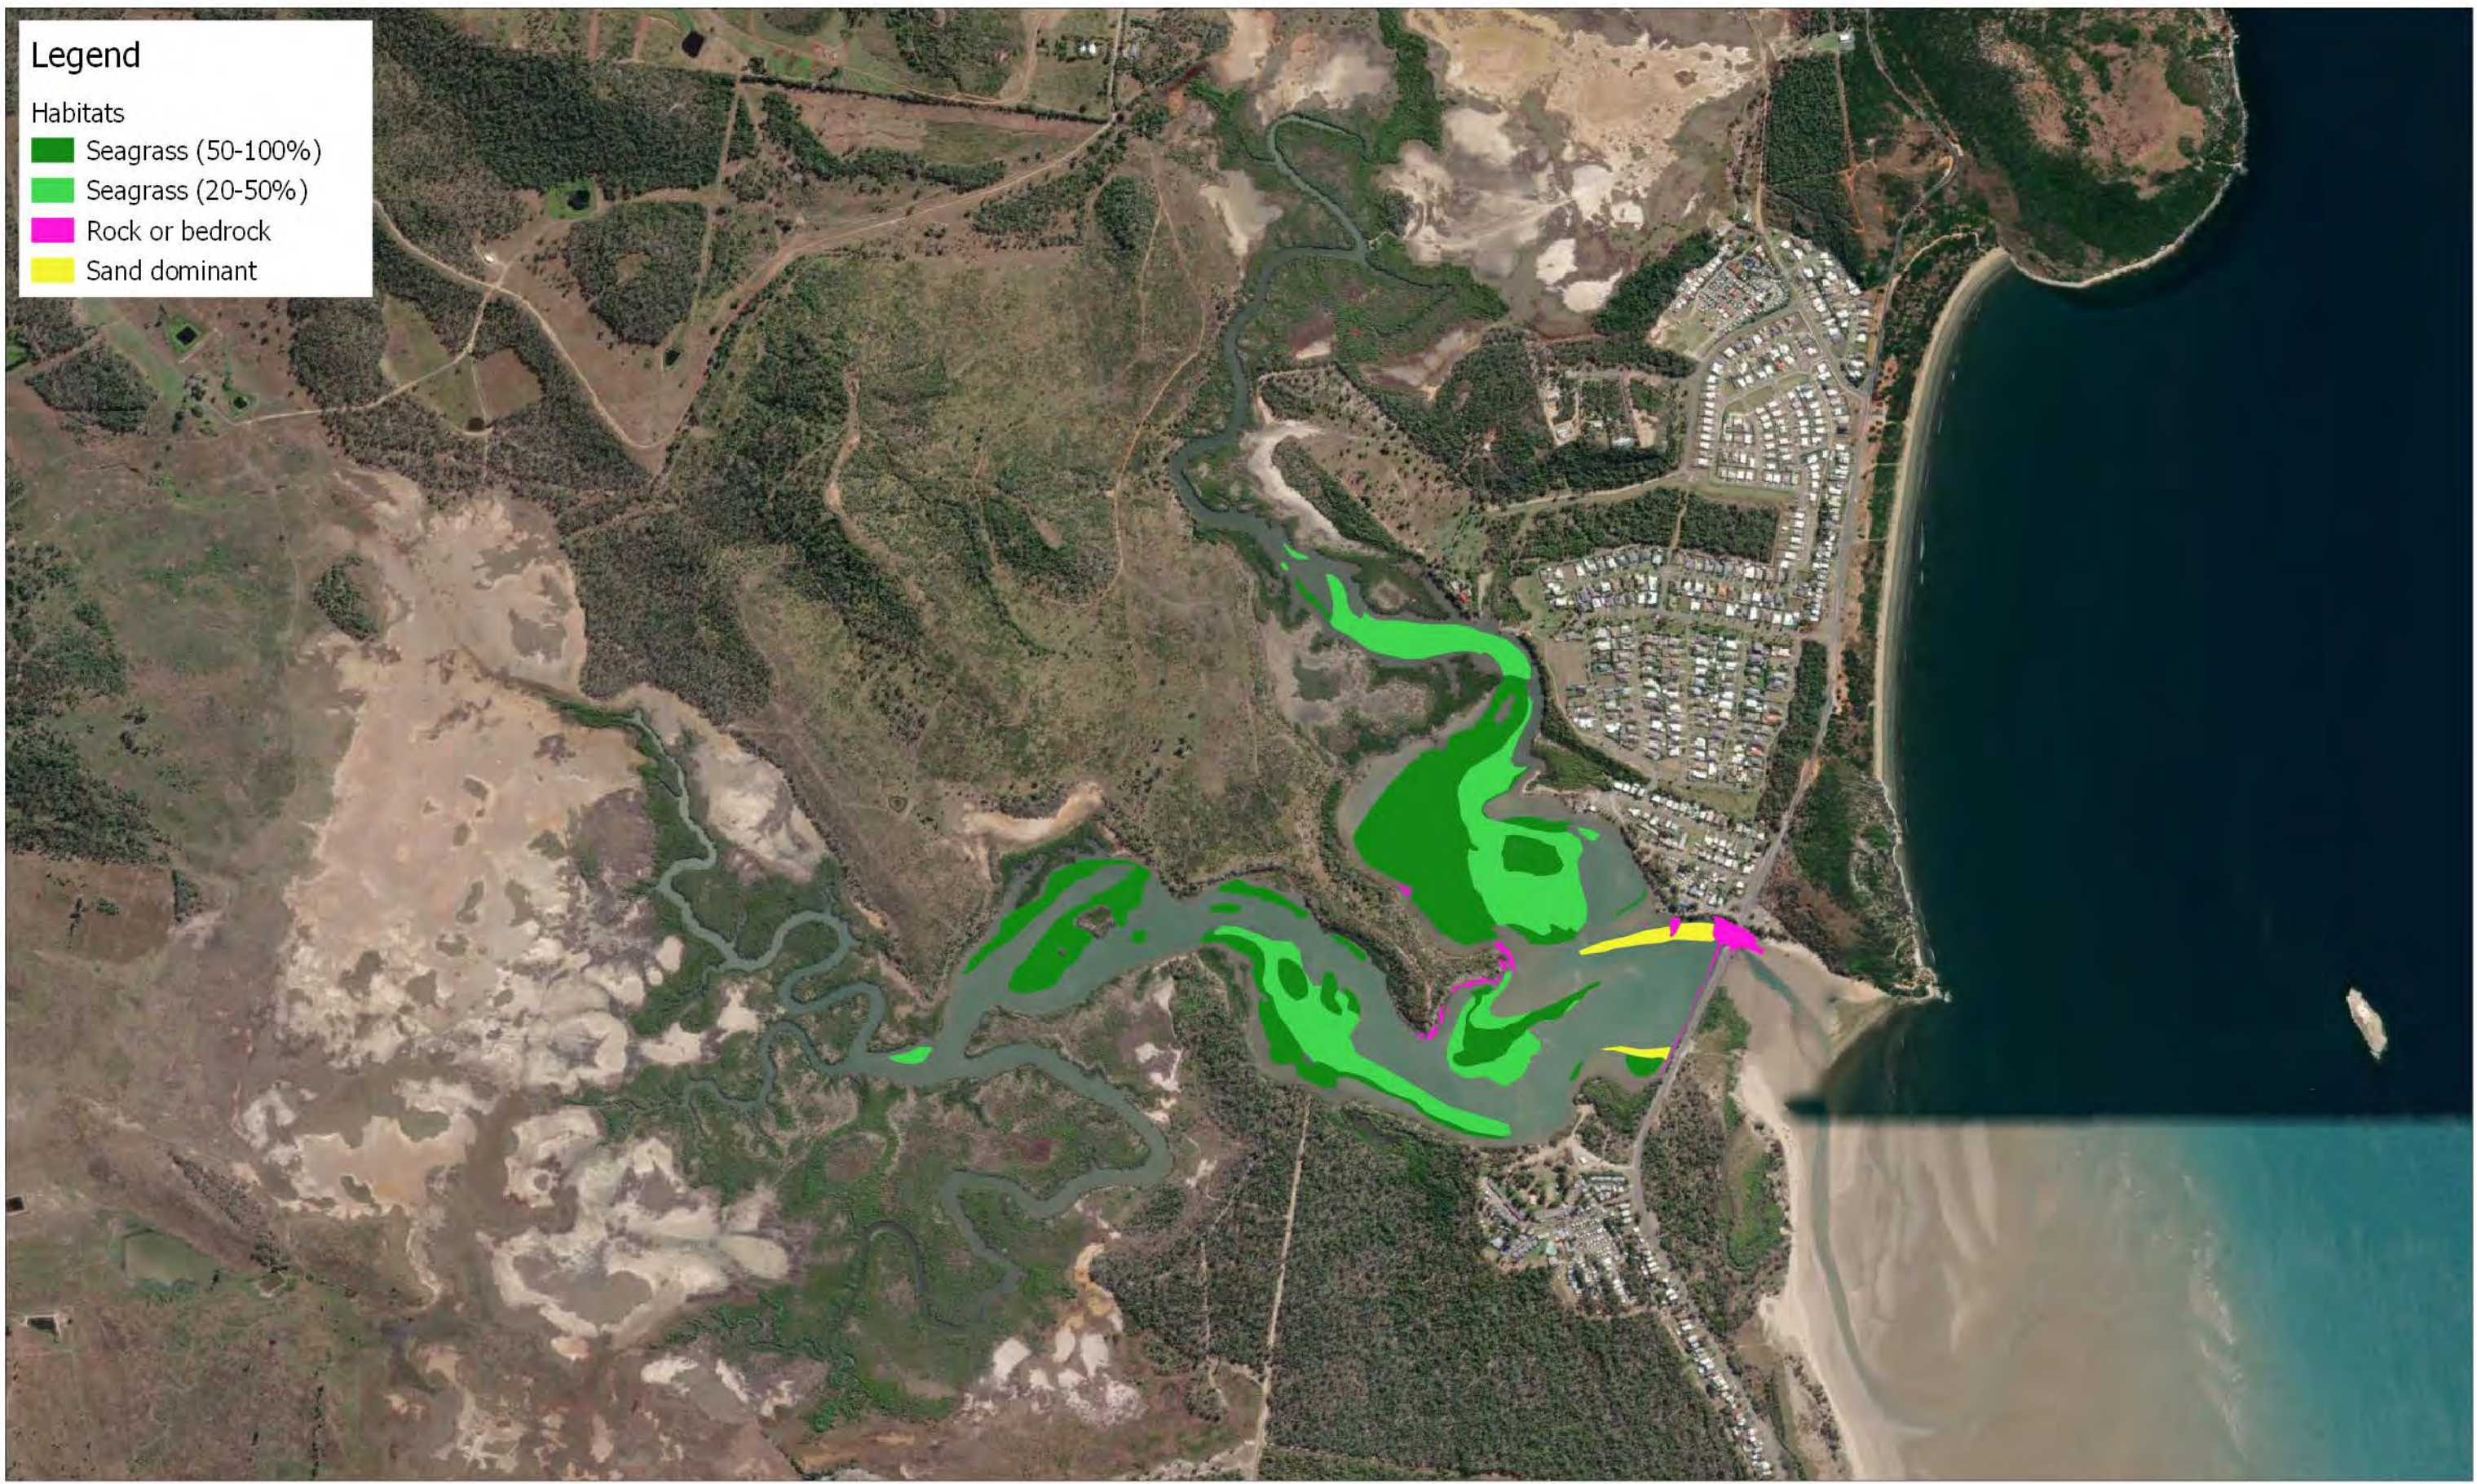
Title:  
**Benthic Habitats**

Figure 4-7 shows the benthic habitat map for the Lake, using inputs of the different mapping methods adopted in this site (details provided in Appendix A). Areas of dense (50-100%) seagrass cover and moderate to dense (20-50%) seagrass cover are shown in this figure. It should be noted that low density seagrass (<5% cover) is likely to exist in many of the areas not covered in the map. The low-density cover does not form meadows and was not observable in satellite or aerial imagery.

The northern section of the Lake, extending into Mulambin Creek, is dominated by a large seagrass meadow. Additional seagrass meadows are present in the southern sections of the lake. It is noted that the seagrass meadows appear to be upper- and lower-limited in the depth-distribution. This is unusual for south-east and central Queensland, as seagrass in this region usually grows in the

intertidal region. In this case, the seagrass meadows typically aligned with the shallower sections of the Lake, but not in the very shallowest sections nor the intertidal areas. This is likely the result of the conditions within the Lake, where the tidal influence depends on the neap and spring tide cycles. During neap tide cycles, the Lake may not achieve connectivity with the ocean and the very shallow areas within the Lake may be prone to high temperatures and excessive solar radiation (BMT 2021).

As discussed in subsequent sections of this report, the seagrass coverage was influential in the evolution of the preliminary design basis, and the environmental offset associated with direct impact to seagrass forms a large cost component within the project budget. It is therefore recommended that additional benthic habitat surveys are completing during the detailed design phase of the project and again prior to the dredging campaign.

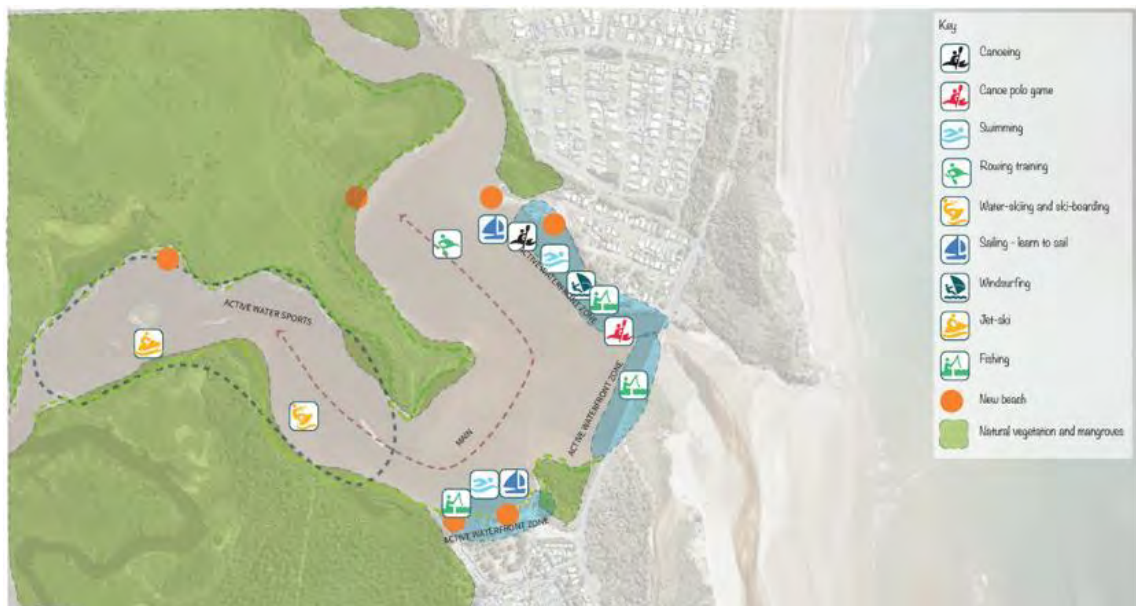
Similarly, Figure 5-2 captures a conceptual layout for future users of the Lake, giving indication of the extended activities requiring access and usage areas. These include motor vessels such as small boats, jet skis, water-skiing and fishing boats, and non-motorised water sports / activities such as paddle sports such as canoeing or rowing, wind sports (small craft sailing and wind surfing), swimming and shore-based fishing.

Figure 5-2 Future users of Causeway Lake (Active Living Landscapes 2016)

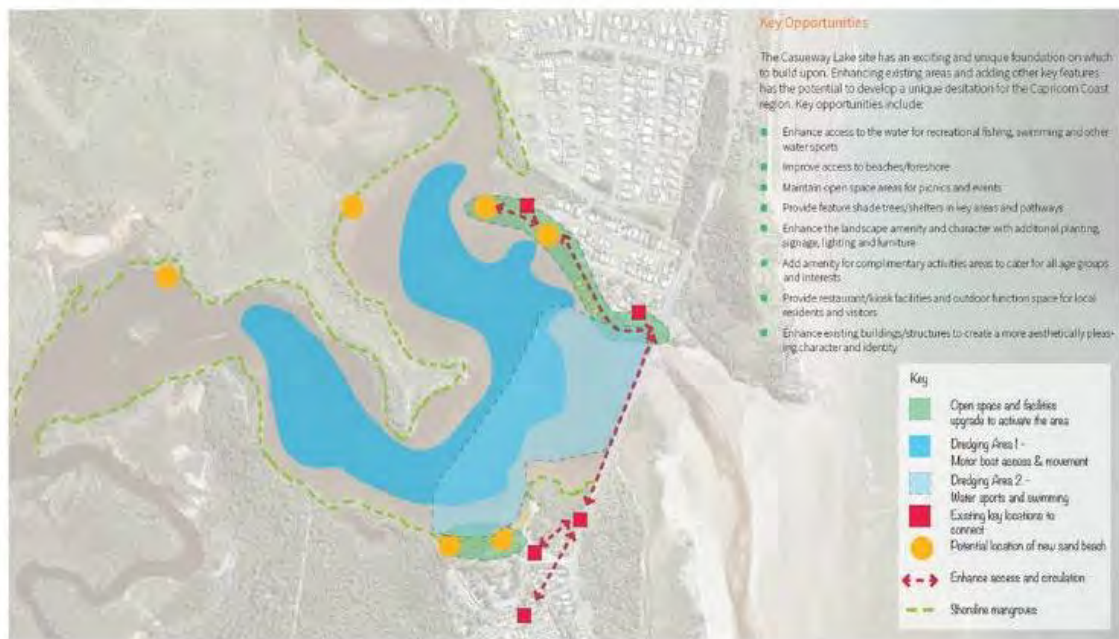
These boundaries were adopted as the preliminary basis for the dredge footprint, following discussions with the Shire in the progress meeting held on 13th May 2021.

**Figure 5-3 Conceptual division of Lake into designated motorboat areas and swimming / water sports areas (Active Living Landscapes 2016)**

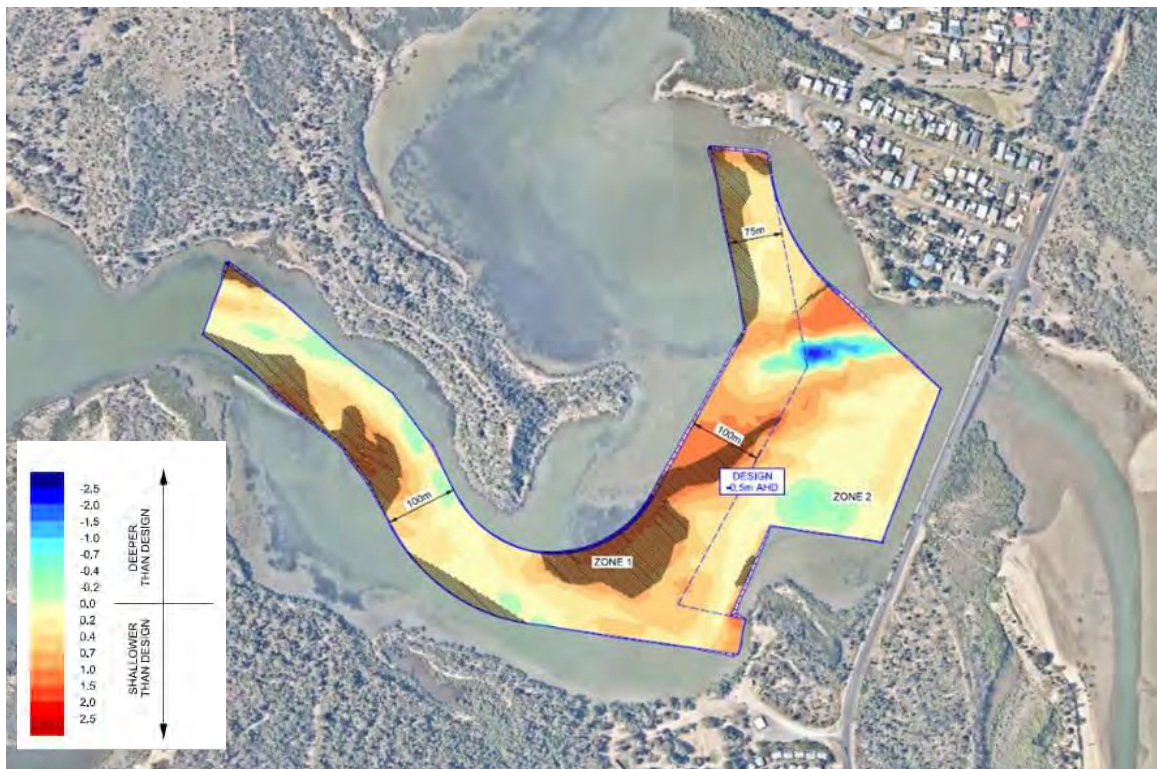
Combining dredge footprint option 3 (Figure 5-6) and a dredge design depth of -0.5m AHD resulted in establishing the basis dredge plan that will be used for the purposes of this assessment (Figure 5-7). The plan was presented and discussed with the Shire during meeting on 10 June 2021.

Figure 5-7 Dredge footprint and depth

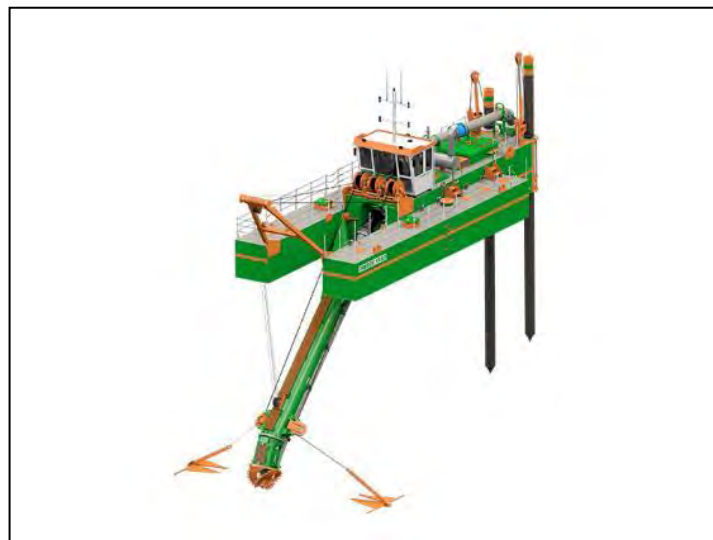
A cutter suction dredge (CSD) uses a rotary cutter head on the end of a 'ladder' to dislodge material from the seabed, which is subsequently raised as a mix with water through a suction pipe within the 'ladder'. Material is then typically pumped as a slurry, through an inboard centrifugal pump, to the placement site through the pipeline transport method (discussed further in Section 6.3.1), although it can also be pumped directly into hopper barges if that method is more suitable. During dredging, the CSD is kept in position using anchors or spud poles; usually a combination of both. The main, or working, spud is used as a reaction point against which the dredge can push forward and move the cutter head into the cut. For dredges with a hydraulic ram system attached to the working spud, the dredge can be moved forward for the length of the spud carriage. The stepping, or auxiliary, spud is used to hold the dredge position while the working spud is reset. The spud also serves as the rotation point at the stern of the vessel. Using a system of anchors and wires, the CSD can rotate around this axis and move the cutter laterally along the seabed.

**Figure 6-1 Typical cutter suction dredge configuration**

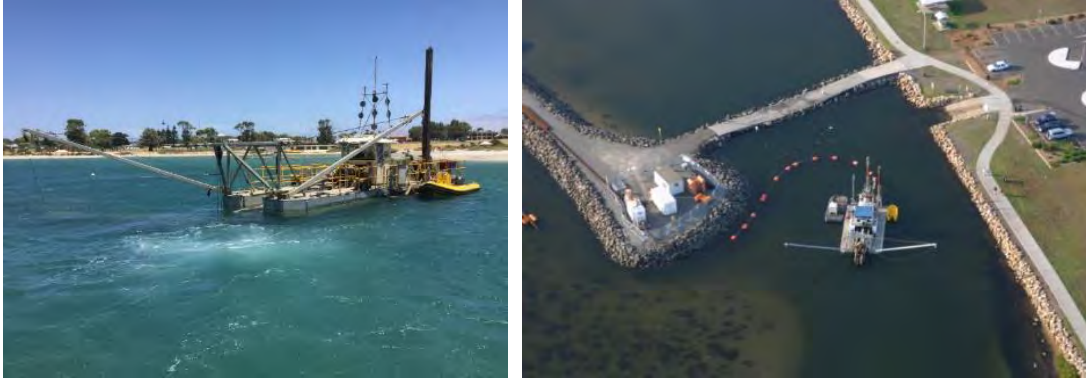
The CSD technique is suitable for dredging unconsolidated and consolidated seabed materials. The technique is also well suited to dredging in shallow water, where the rotary cutter head can excavate a passage in front of the dredge. The CSD technique is less suited to dredging in areas of high traffic vessel operations, as it is time consuming to move the dredge off-line and out of the navigation area to allow the passage of a vessel, and then to relocate the CSD over the progressively dredged

interface. In comparison to mechanical dredging methods, CSD dredging can result in significant disturbance of the materials being dredged, leading to larger turbidity and plume generation. This needs to be considered in the environmental risk assessment and may require monitoring during the dredge campaign.

Figure 6-2 Cutter suction dredges

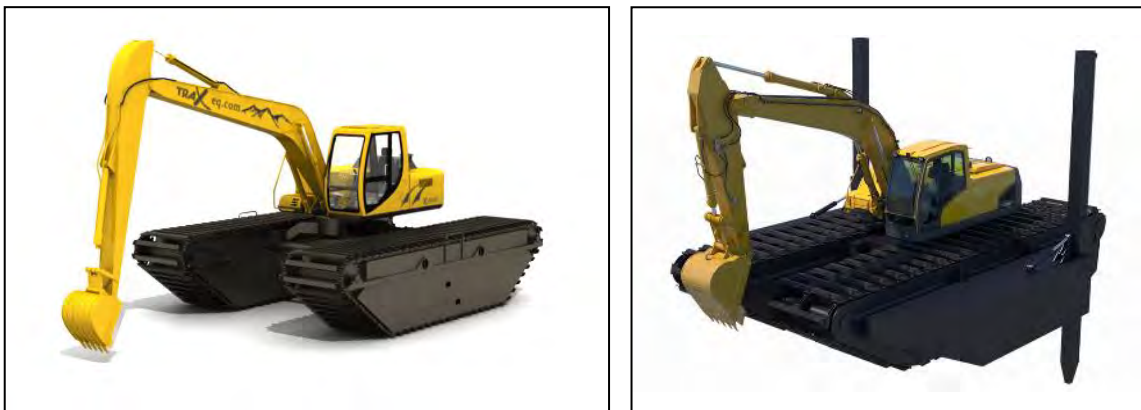
An amphibious excavator is a customised standard or long-reach excavator where the chassis crawler floats on a sealed pontoon (Figure 6-4). Amphibious excavators are well suited to manoeuvre in marshy, swampy area and soft terrain, as well as being able to float on the water. For added stability in deeper water, supplementary pontoons with a hydraulic-mechanical spud system can be attached to the outer side of the primary pontoons.

Figure 6-4 Amphibious excavator. Left: standard watertight pontoons, Right: supplementary pontoons with hydraulic-mechanical spud system

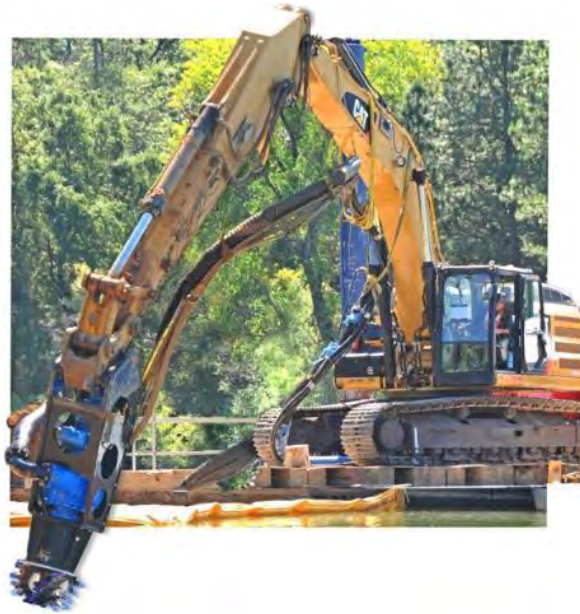
The excavator is usually fitted with a backhoe, following the same excavation mechanics as a mechanical land-based unit. However, some plants can accommodate a cutter head (Figure 6-5). This allows the amphibious excavator to operate along the same principles as a CSD. The material is dislodged by the cutter head, raised as a slurry mix with water through a flexible suction pipe and is subsequently pumped through a special pump, fitted within the boom of the excavator, to the placement site through the pipeline transport method. The setup has the benefit of being able to move unassisted between the shoreline and the waterbody, removing the need for ramps or specific

cranes at the mobilisation and demobilisation stages. The excavator's proficiency in soft grounds mean it is better suited for launching off the existing natural slopes along the shoreline, reducing the site preparation works and costs.

**Figure 6-5 Amphibious excavator fitted with a rose cutter attachment (source: Eddy pump 2021)**

Another advantage of the amphibious excavator is the option for both the backhoe and cutter head attachments. Use of the backhoe could be useful for the dredging of areas adjacent to intended lakeshore placement sites (discussed further in Section 7), where excavated material can be placed more effectively without the need for the pipeline transport system.

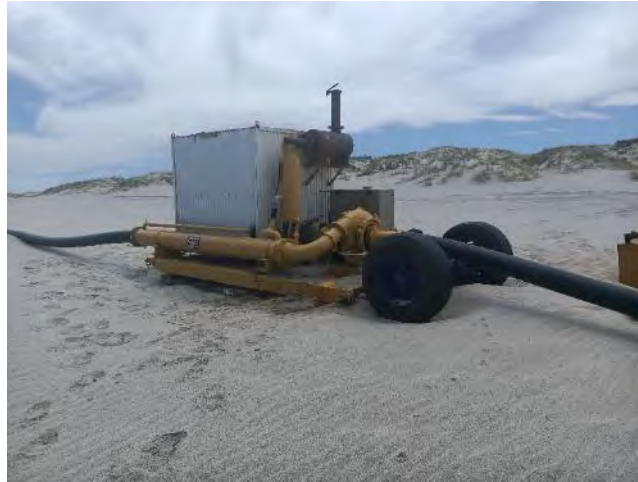
Additional booster pumping stations (Figure 6-6), can be situated along the pipeline route to extend the pumping distance; however, these substantially add to the project costs and can cause significant disturbance during operation due to noise.

**Figure 6-6 Pipeline booster pumping station**
