# Causeway Lake Dredging - Engineering Feasibility Evaluation

Reference: R.A10946.002.02.DredgingFeasibility.docx  
Date: September 2021  
Confidential

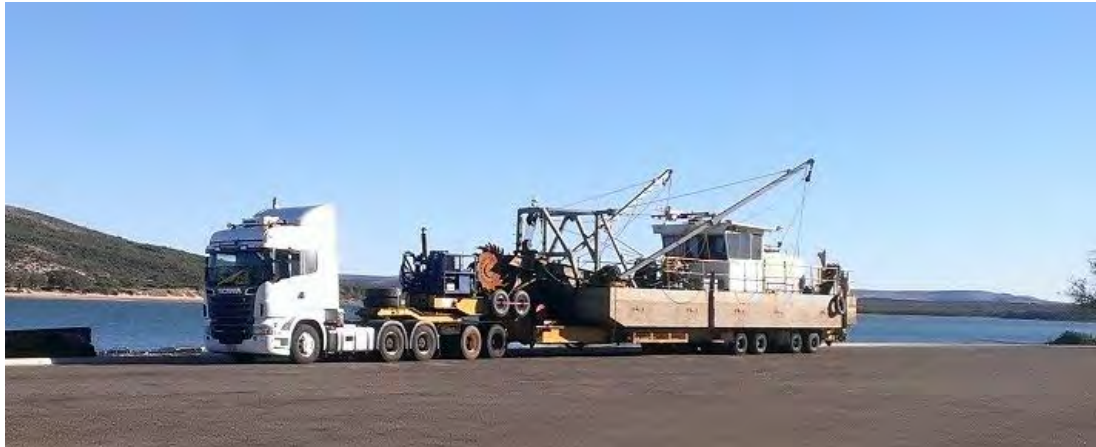
These small type dredges are transportable as a single unit, either on the back of a semi-trailer (Figure 6-8) or within a shipping container (for auger units only). In many cases, the trailers are designed to function as a slipway for loading the dredge in and out of the water (Figure 6-9) provided there is a suitable ramp.

**Figure 6-8 Small CSD loaded onto a semi-trailer for road transport**

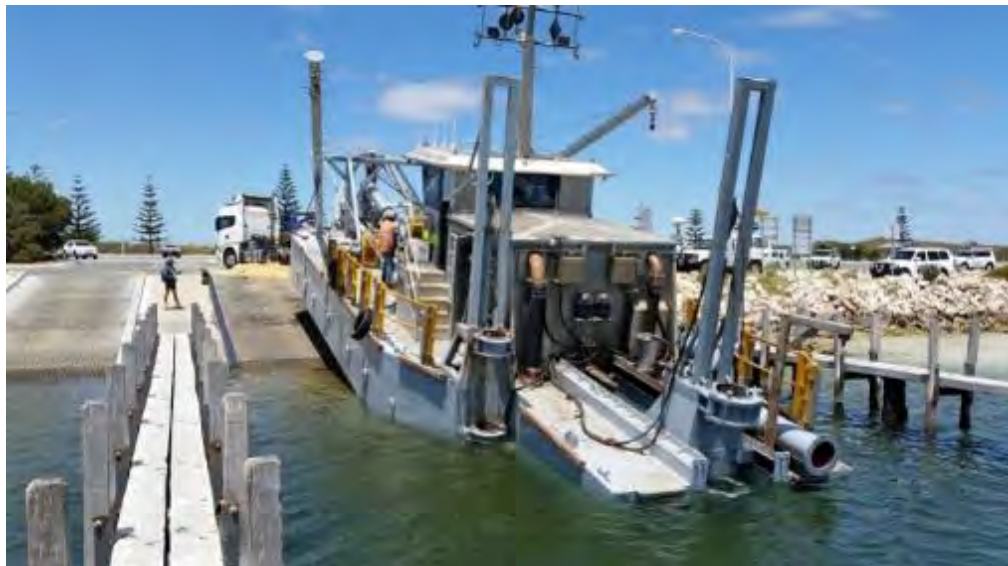
**Figure 6-9 Launching of a small CSD off a semi-trailer, at a commercial boat ramp**

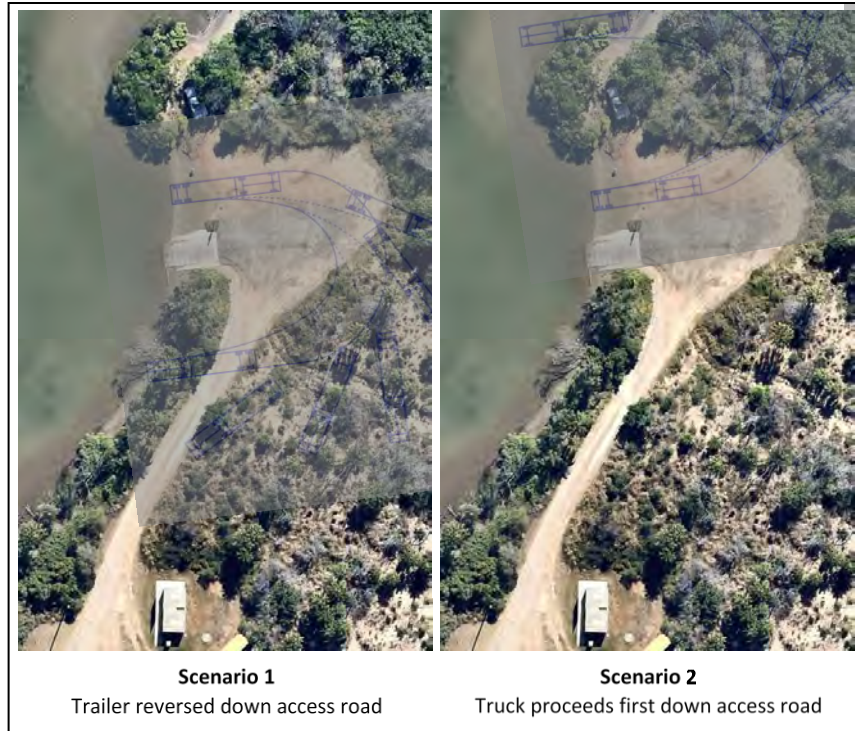
Figure 6-10 Schematic - Compatibility of natural ramp area with a 19 m x 3.8 m trailer/truck combination

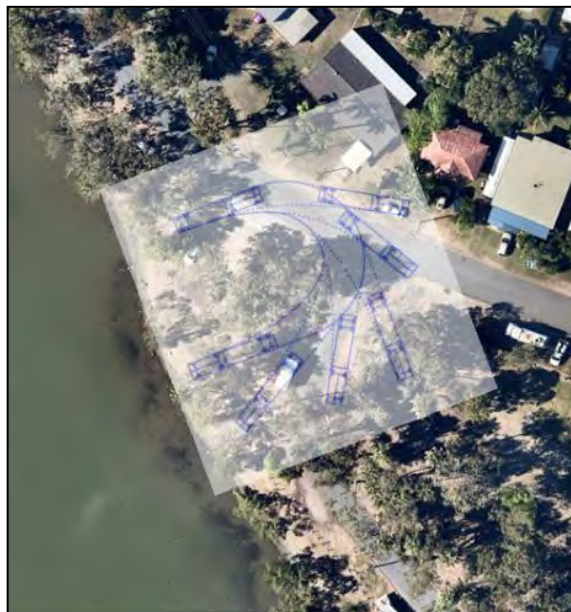
The Lake northern ramp is also likely to have access issues in its current configuration. Figure 6-11 suggests the orientation of the road is more accommodating for truck/trailer combination in comparison to the southern ramp. However, the existing ramp is very restrictive in terms of width and height, and unlikely to be compatible with any trailer launched dredges.

Figure 6-11 Schematic - Compatibility of the northern ramp area with a 19 m x 3.8 m trailer/truck combination

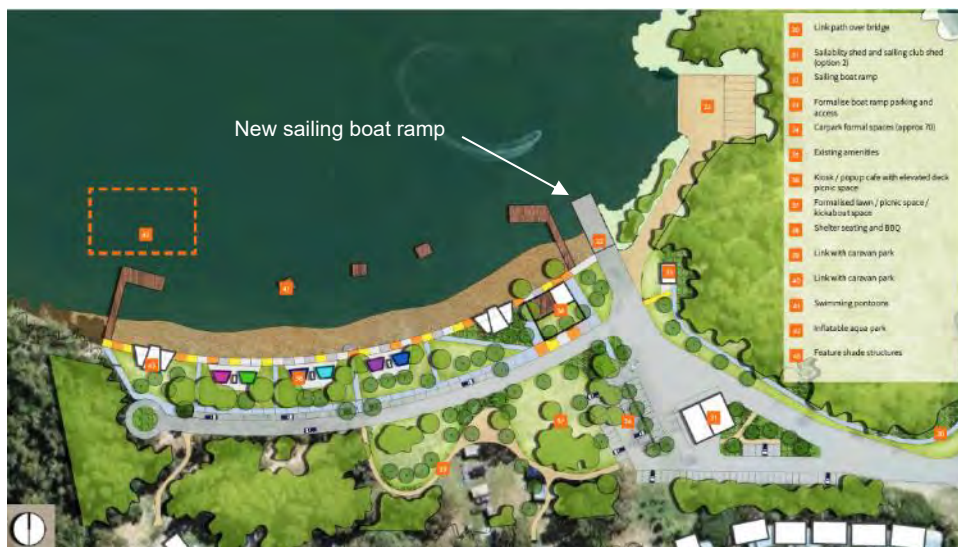
For example, the preliminary master plan indicates the construction of a new sailing boat ramp at the bend of Resada Esplanade (Figure 6-12). Considering the predominant vessel fleet frequenting the Lake is small recreational vessels, this ramp is likely to be of similar design capacity to the existing concrete ramp. Although the final ramp would be unsuitable for launching the dredge, the campaign could capitalise on the vegetation clearing for the shoreline development and build a temporary gravel ramp. The location already provides sufficient room to manoeuvre a truck and trailer to the shoreline, so there would be no requirement for a new access route from the Scenic Highway.

**Figure 6-12 New southern sailing boat ramp, as proposed in preliminary master plan (Active Living Landscapes 2016)**

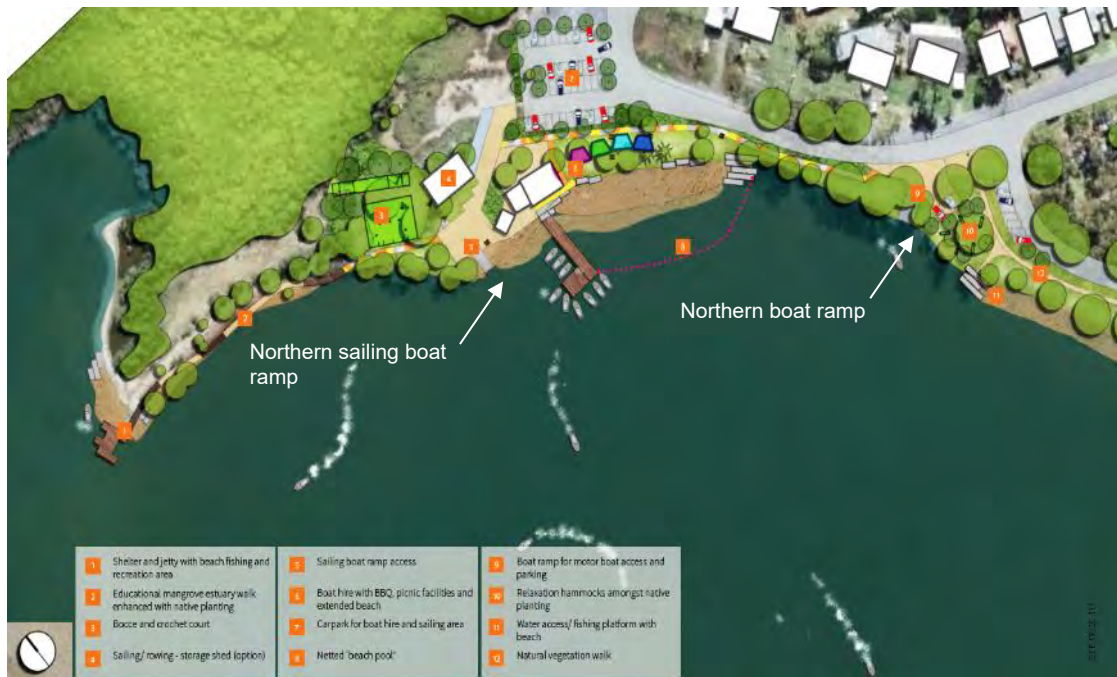
The northern ramp presents a similar opportunity for achieving joint objectives. However, from the preliminary master plan (Figure 6-13) it appears large scale shoreline development is not planned for this area and the ramp is likely to remain unchanged or be upgraded to a concrete ramp of comparable size. Future revision of the master plan could consider a larger scale development of this area, with the required vegetation clearing for dredge mobilisation, however, this is likely to have a greater community impact. The northern ramp is situated close to the residential community and significant alteration of the shoreline vegetation may be poorly received by the community stakeholders.

The redevelopment of the ramp adjacent to the boat shed, also shown in Figure 6-13, may present a better opportunity on the northern shore. The preliminary master plan proposes a ramp suitable for sailing boat launching and retrieval but does not give indication on whether the ramp will be upgraded from the existing concrete slab. This area can be considered for inclusion as a potential launching/retrieval site in future planning studies.

**Figure 6-13 Northern redevelopments, as proposed in preliminary master plan (Active Living Landscapes 2016)**

- North of the Boat Shed (shown in Figure 6-13) however this is close to the residential area and the Boat Shed itself; or
- Near the southern boat ramp, which may require the temporary road closure and/or some vegetation clearing.

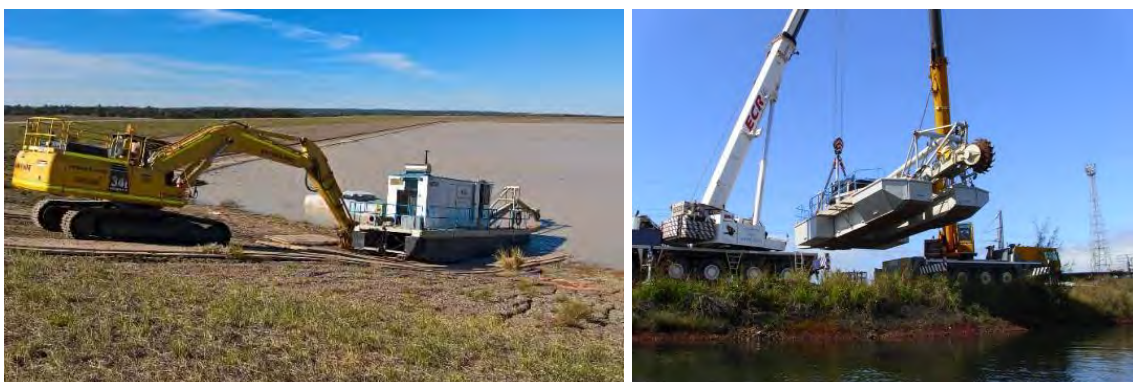
**Figure 6-14 Left: Mini CSD pushed into the waterway with a medium size excavator; Right: CSD launching with a two-crane lift**

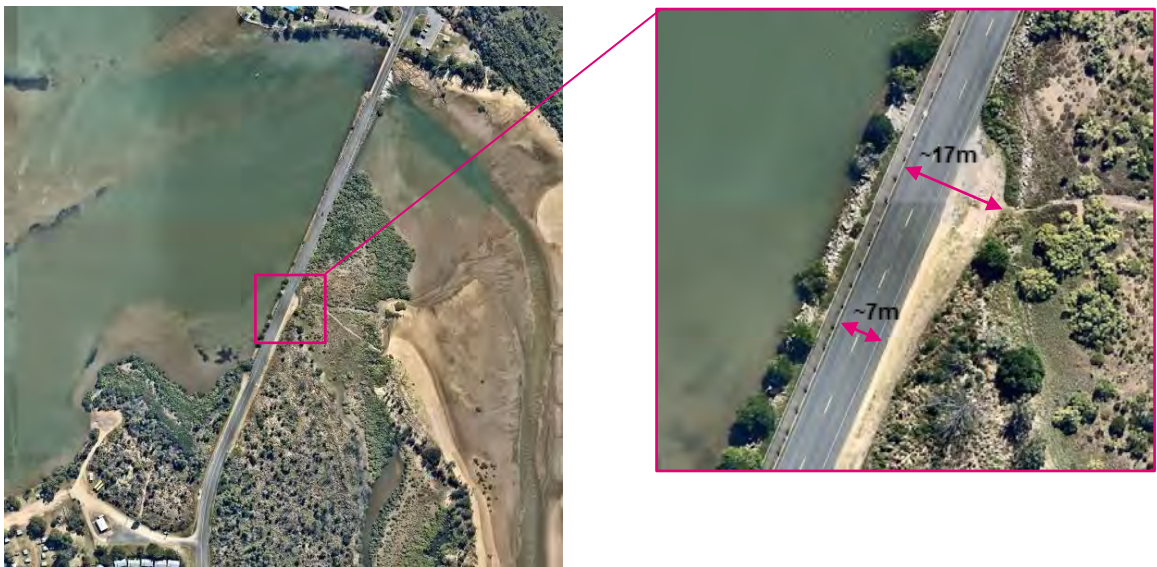
**Figure 6-15 Restricted widths along causeway**

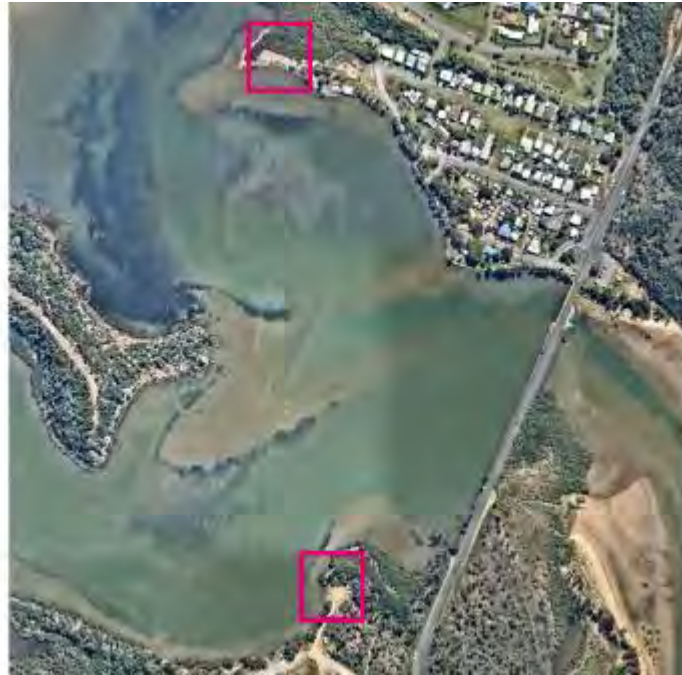
Figure 6-16 Potential launching sites for amphibious excavator in Causeway Lake

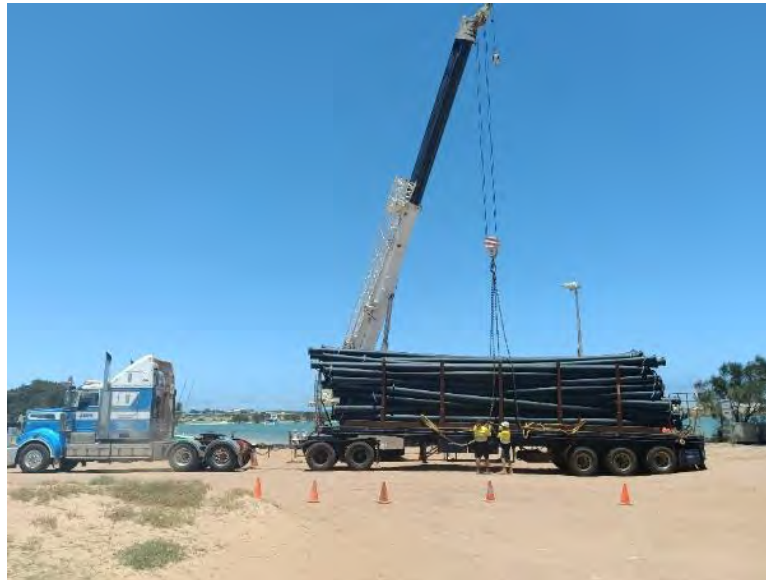
- The slurry pipe rack/s. These are transported to site on semi-trailers and unloaded with a crane (Figure 6-17). The pipeline is assembled, managed and disassembled with a small spread of earthmoving equipment.
- A large fuel tank (~10,000L)
- Site containers (mechanical workshop, spares, ablution facilities, site office if required).

Figure 6-17 Unloading of pipe racks from semi-trailer

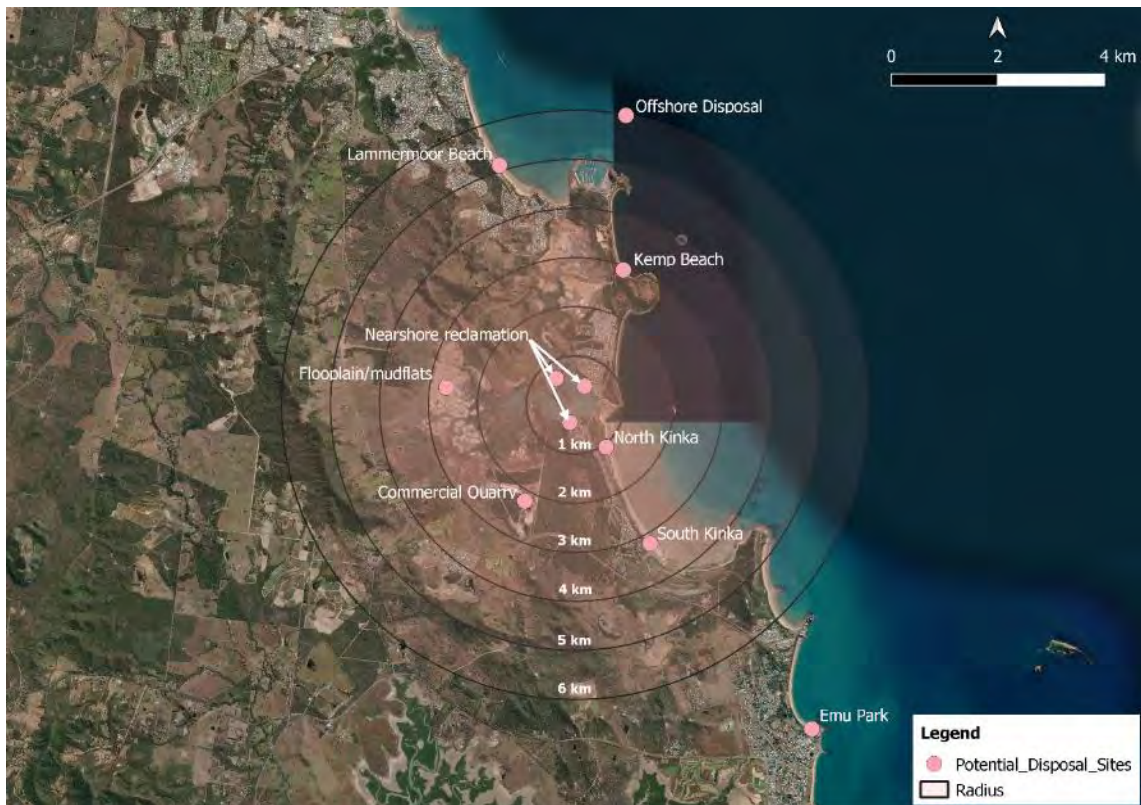
**Figure 7-1 Summary of potential material placement sites**

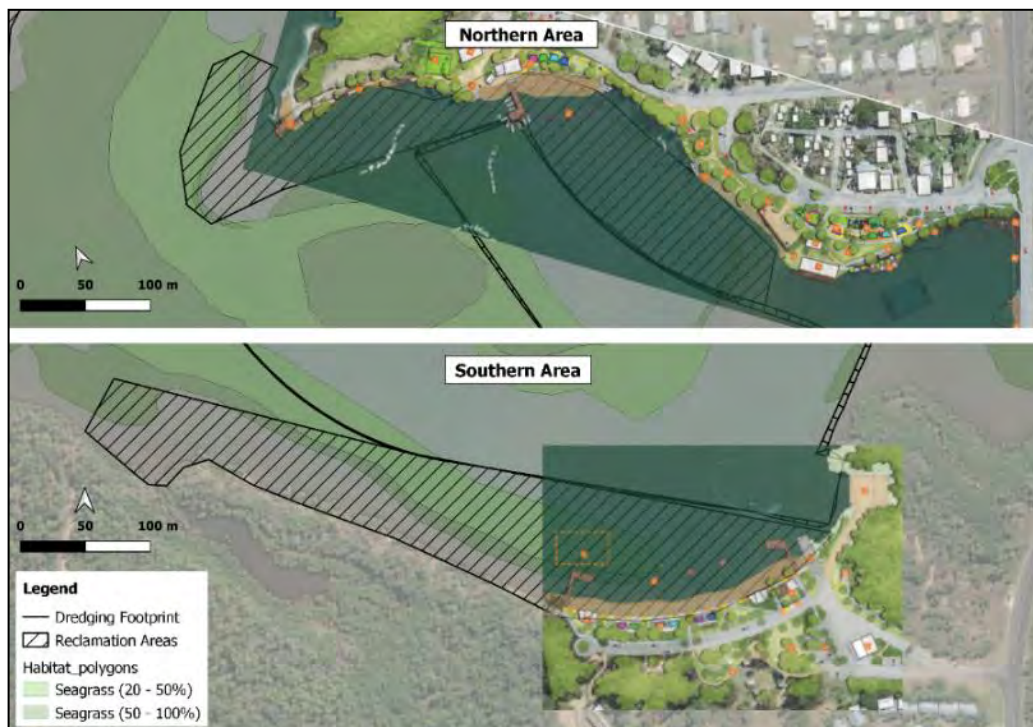
Figure 7-3 Potential beach reclamation sites for the northern and south sections of Causeway Lake

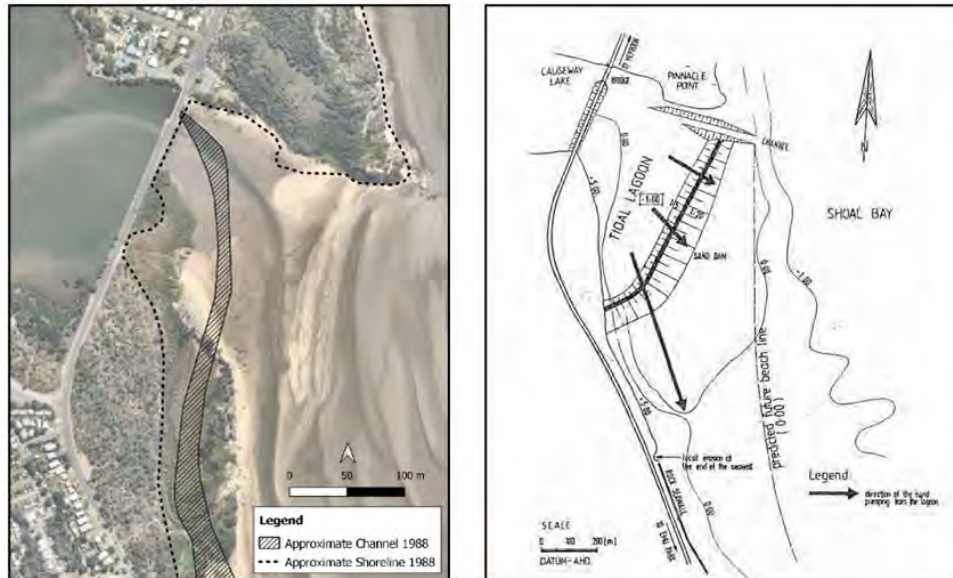
Placement of material along North Kinka Beach is recommended as a secondary location for remaining material, following reclamation of nearshore locations within the Lake. The two main characteristics of the beach are the broad tidal flats extending seaward, with slopes of above 1 in 500 between the mean sea level and the low water level (Beach Protection Authority, 1979), and the tidal channel connecting the Lake to the ocean. The area around Pinnacle Point experienced substantial change following the construction of the causeway in 1939 and now features a large sand spit extending southwards from Pinnacle Point. This sand spit forces the alignment of the tidal channel to follow the line of the frontal dunes at North Kinka Beach, which has been suggested to be a causal factor in the continual erosion of the beach, as it transports sand away from the system (Grigg and Piorewicz, 1989). The erosion of this area has historically presented a risk to the Scenic Highway and private properties along the beach. Management efforts in 1988 saw the excavation of a new tidal channel adjacent to Pinnacle Point. The excavated material was used to create a sand dam extending north-easterly from the existing beach, as seen in Figure 7-5. The purpose of the sand dam was to restrict flow through the old channel alignment, increasing the stability of the dredged channel (Piorewicz, 1990). It was estimated that a total of 15,000 m<sup>3</sup> of material was relocated in the operation. Gradually, the tidal lagoon partially infilled with sediment and new mangrove growth emerged. The channel eventually reverted to a southerly orientation, albeit westerly of its original path. A possible explanation for this is the reduction in tidal prism as the tidal dam infilled, reducing the volume and rate of flow through the channel and leaving it susceptible to accretion.

**Figure 7-5** Left: approximate location of the shoreline and tidal channel in 1988 against May 2021 aerial imagery, Right: realignment of the tidal channel and orientation of the sand dam (Piorewicz, 1990)

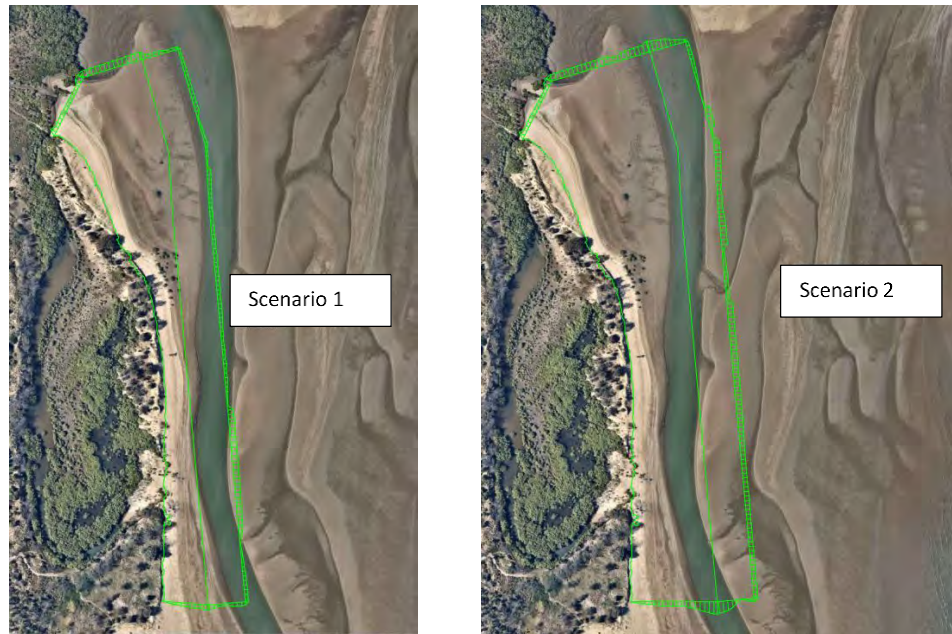
Figure 7-6 North Kinka Beach conceptual beach nourishment footprints

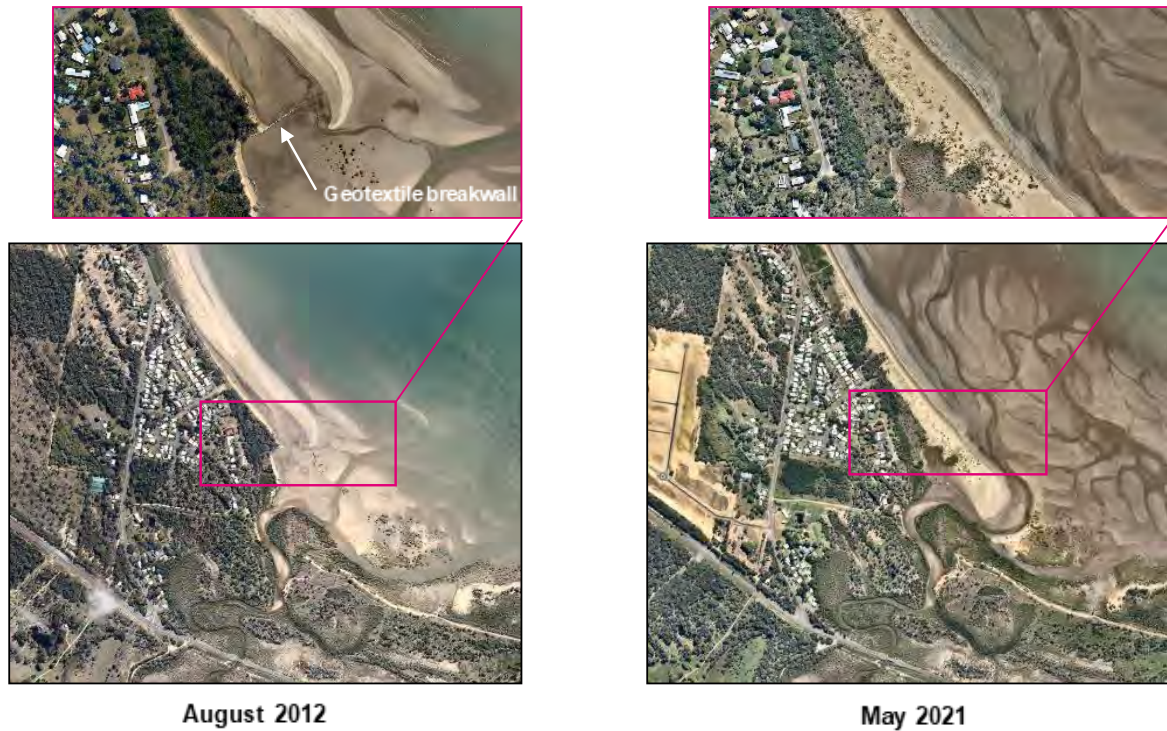
**Figure 7-7 Comparison of South Kinka Beach, August 2012 to May 2021**

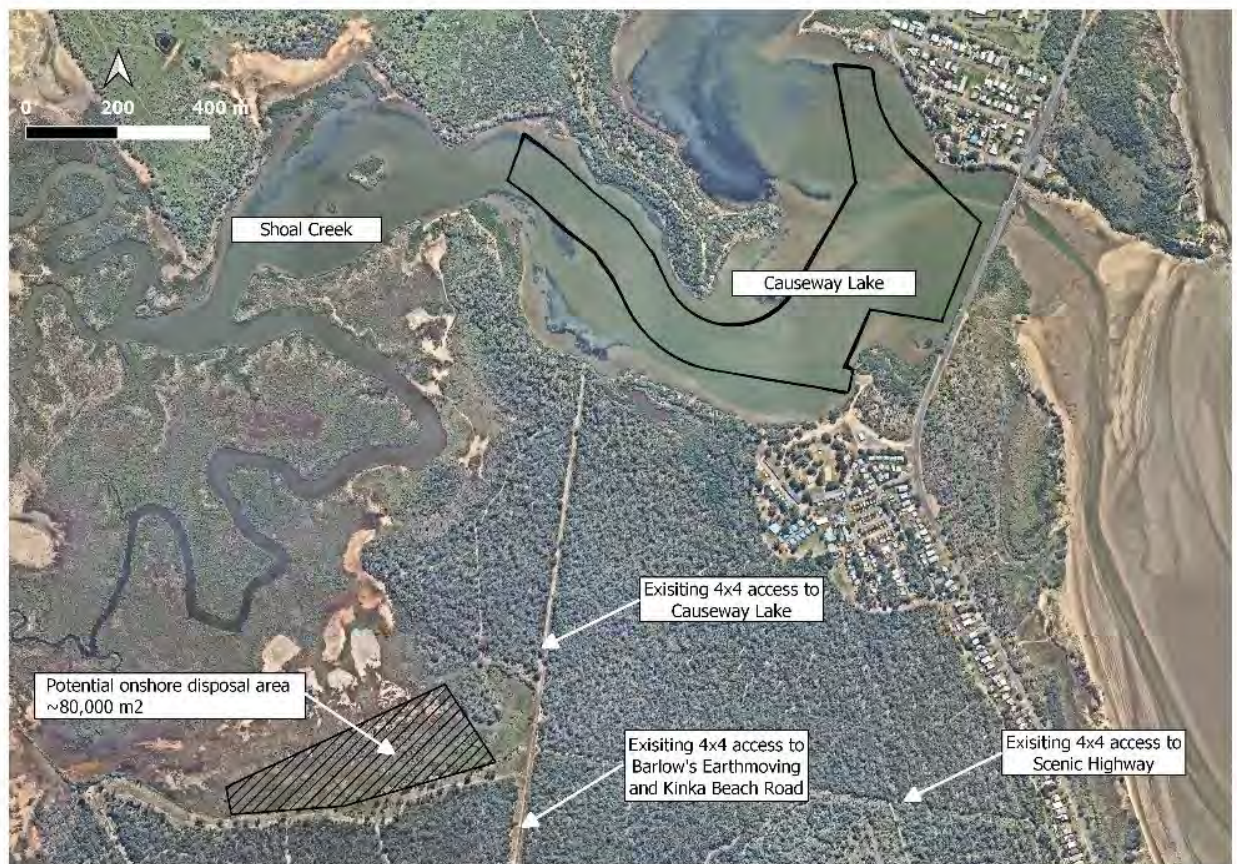
Figure 7-8 Potential indicative onshore disposal area

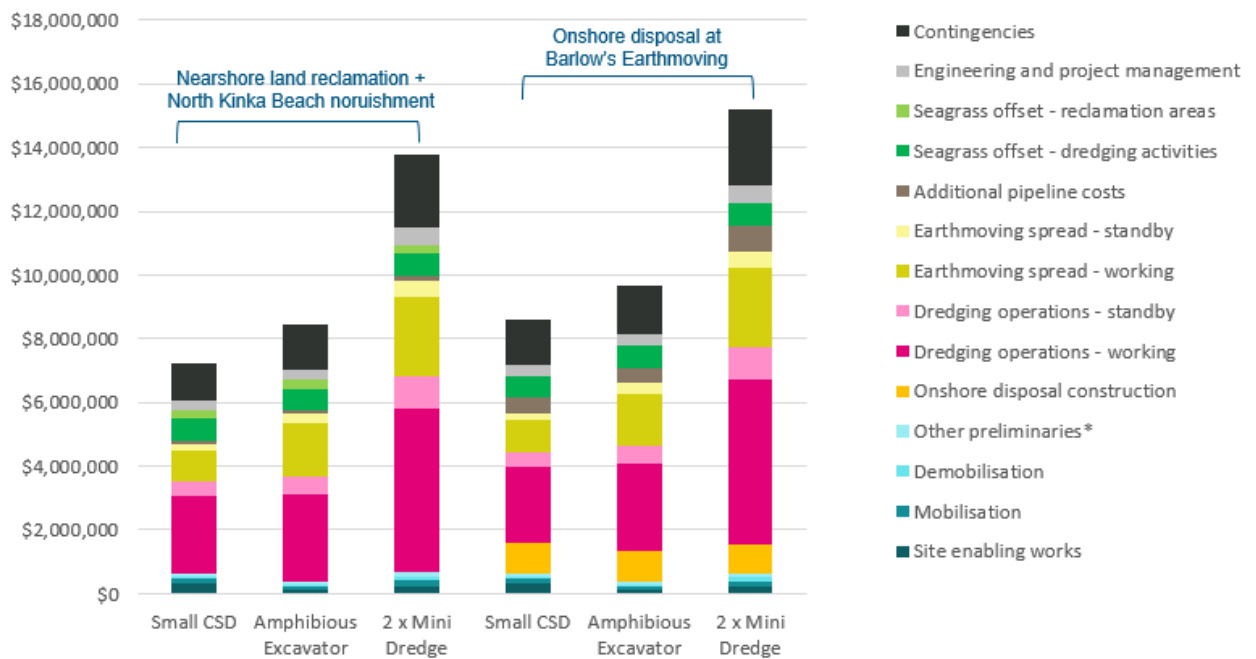
**Figure 9-1 Comparison of dredging costs**

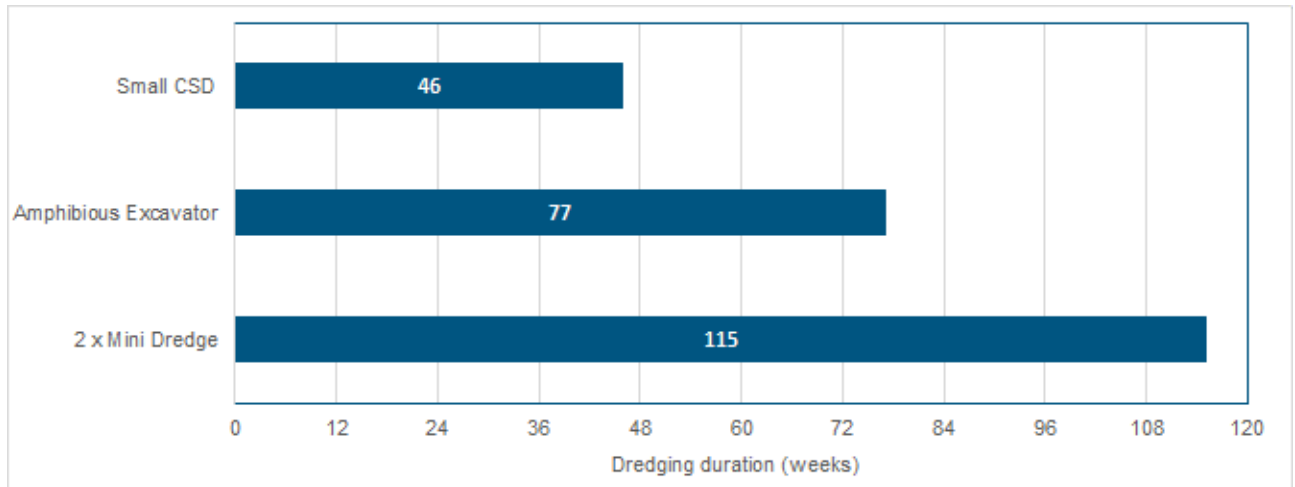
**Figure 9-2 Estimated project durations**

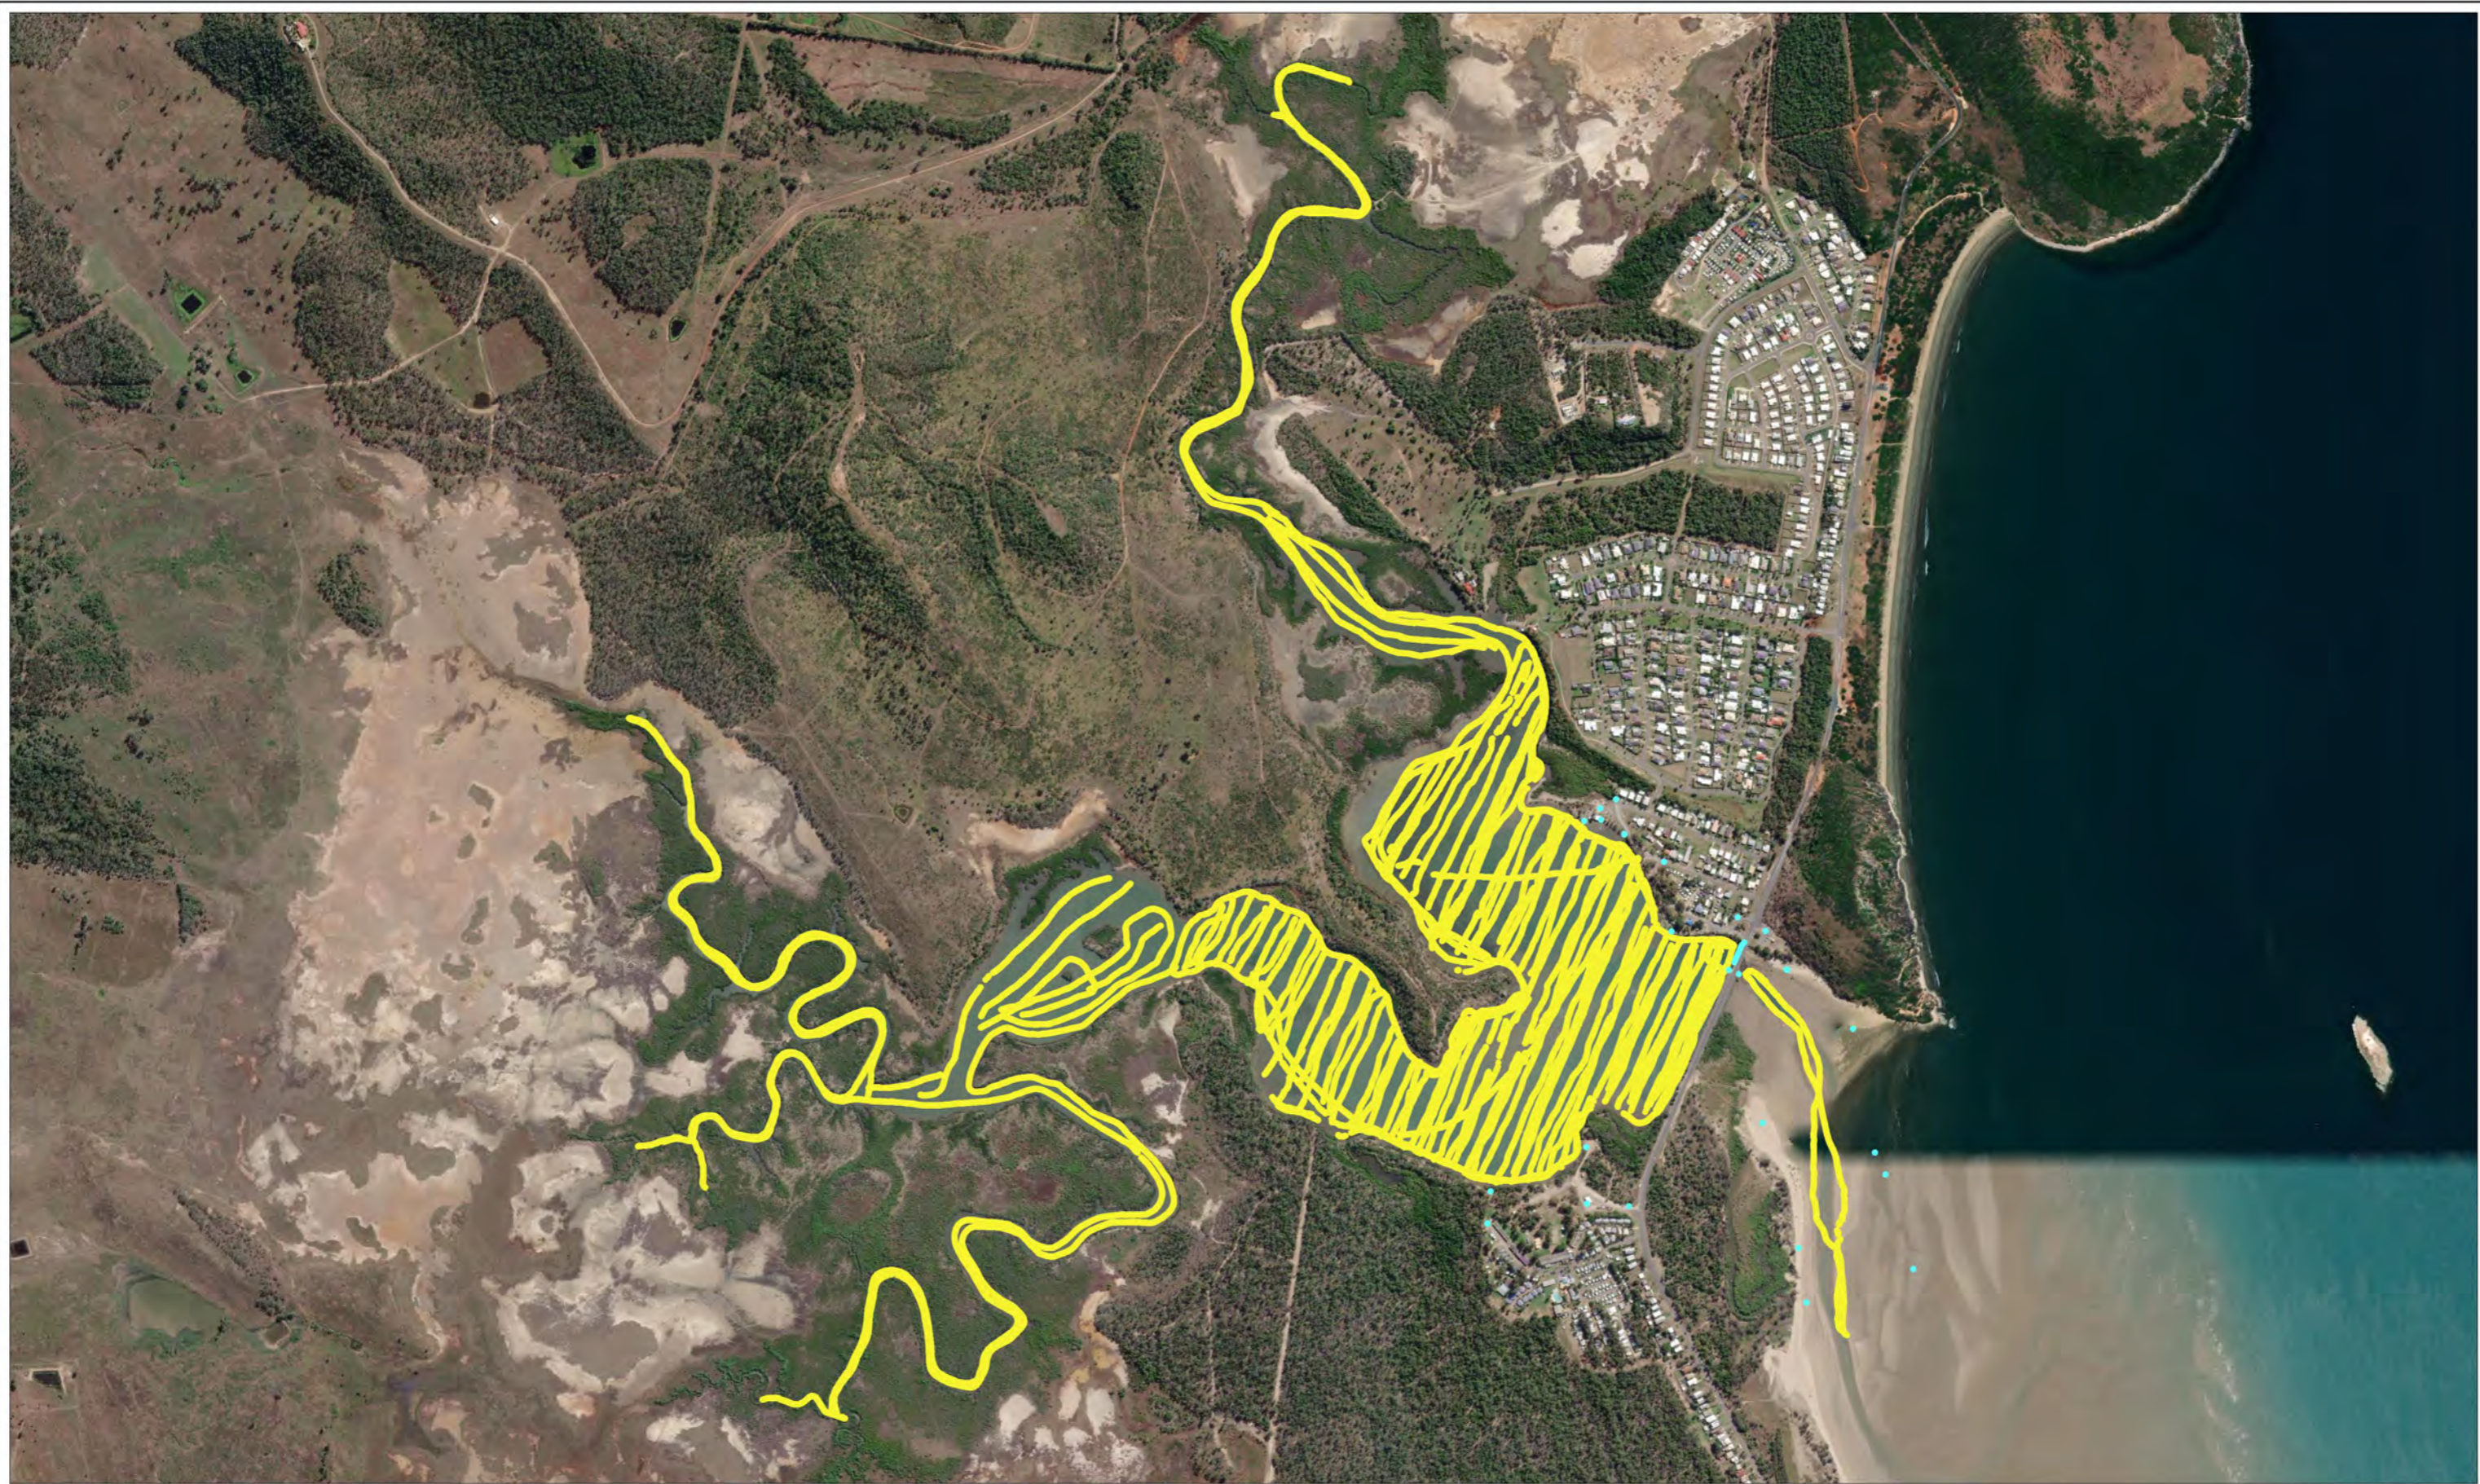
- RTK Land Survey Points
- 2021 Survey Points

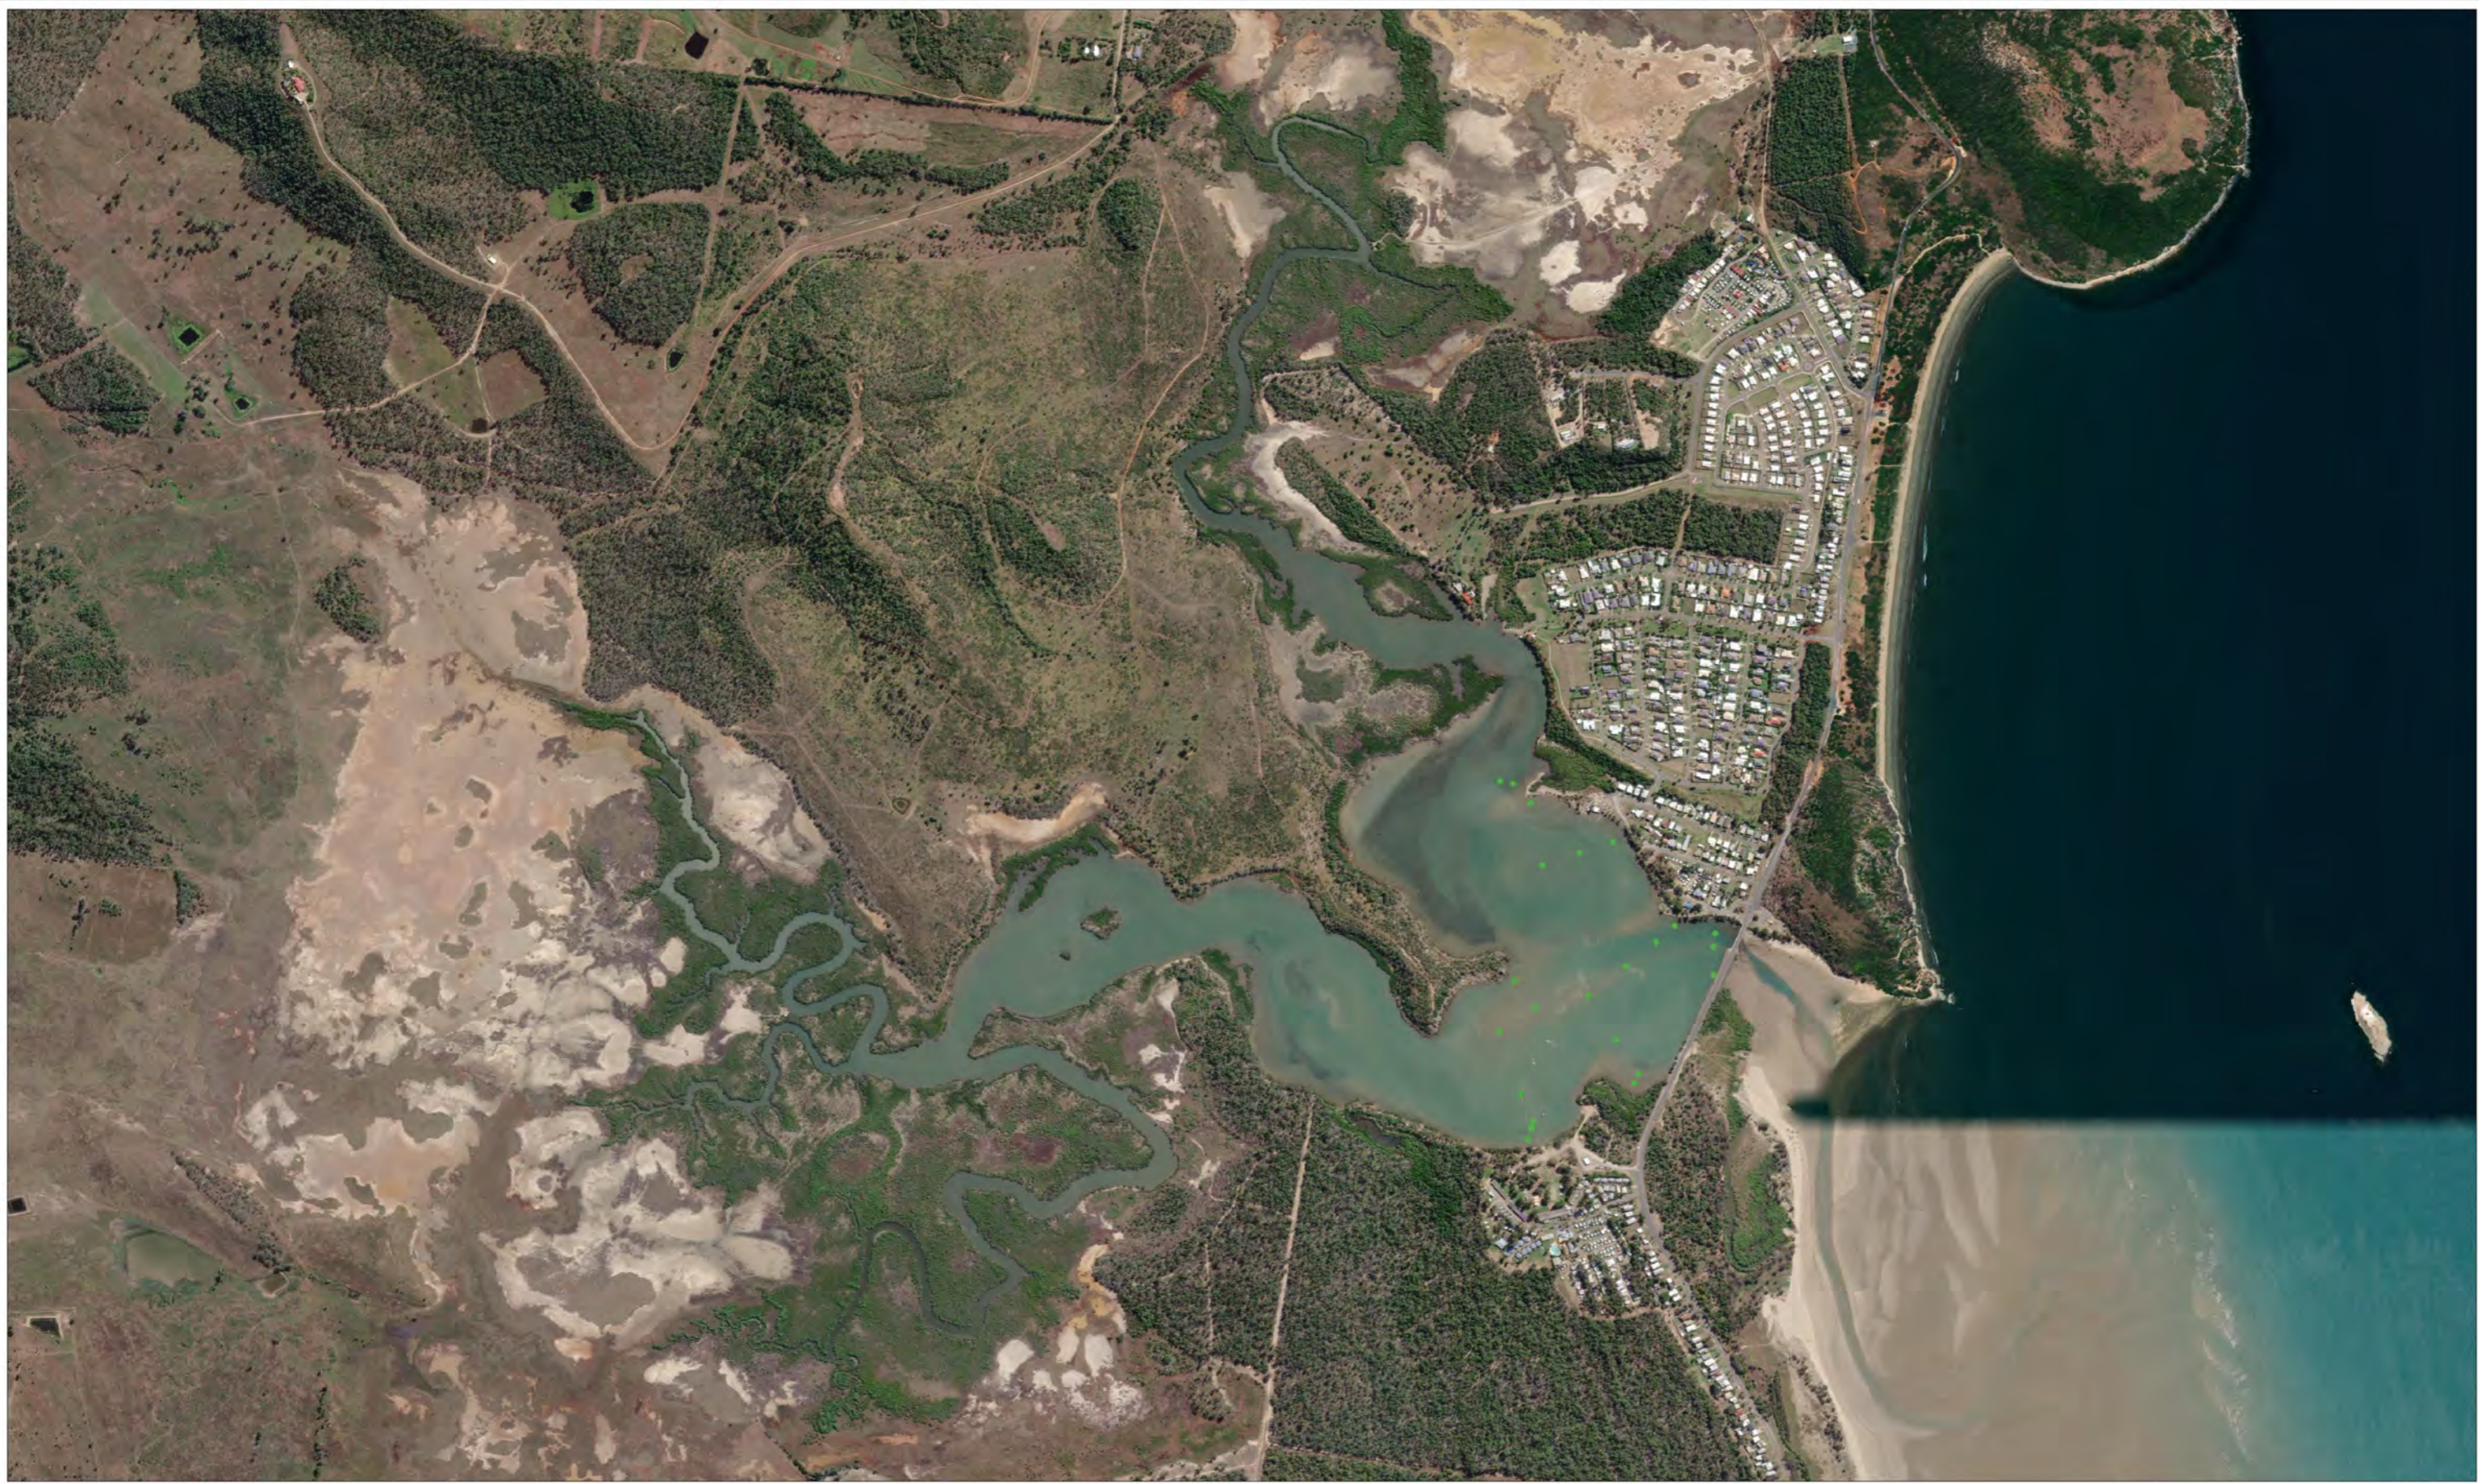
A high-resolution drop camera with live surface feed was used to ground truth-seagrass meadows at locations shown in Figure 2-2. Transects were conducted over 10-20 m drifts as appropriate to the patch size of habitat in question. Seagrass was also sampled from meadows observed from the surface at four meadows to confirm species identifications.

- Seagrass ground-truthing locations
