# Causeway Lake Dredging - Engineering Feasibility Evaluation

Reference: R.A10946.002.02.DredgingFeasibility.docx  
Date: September 2021  
Confidential

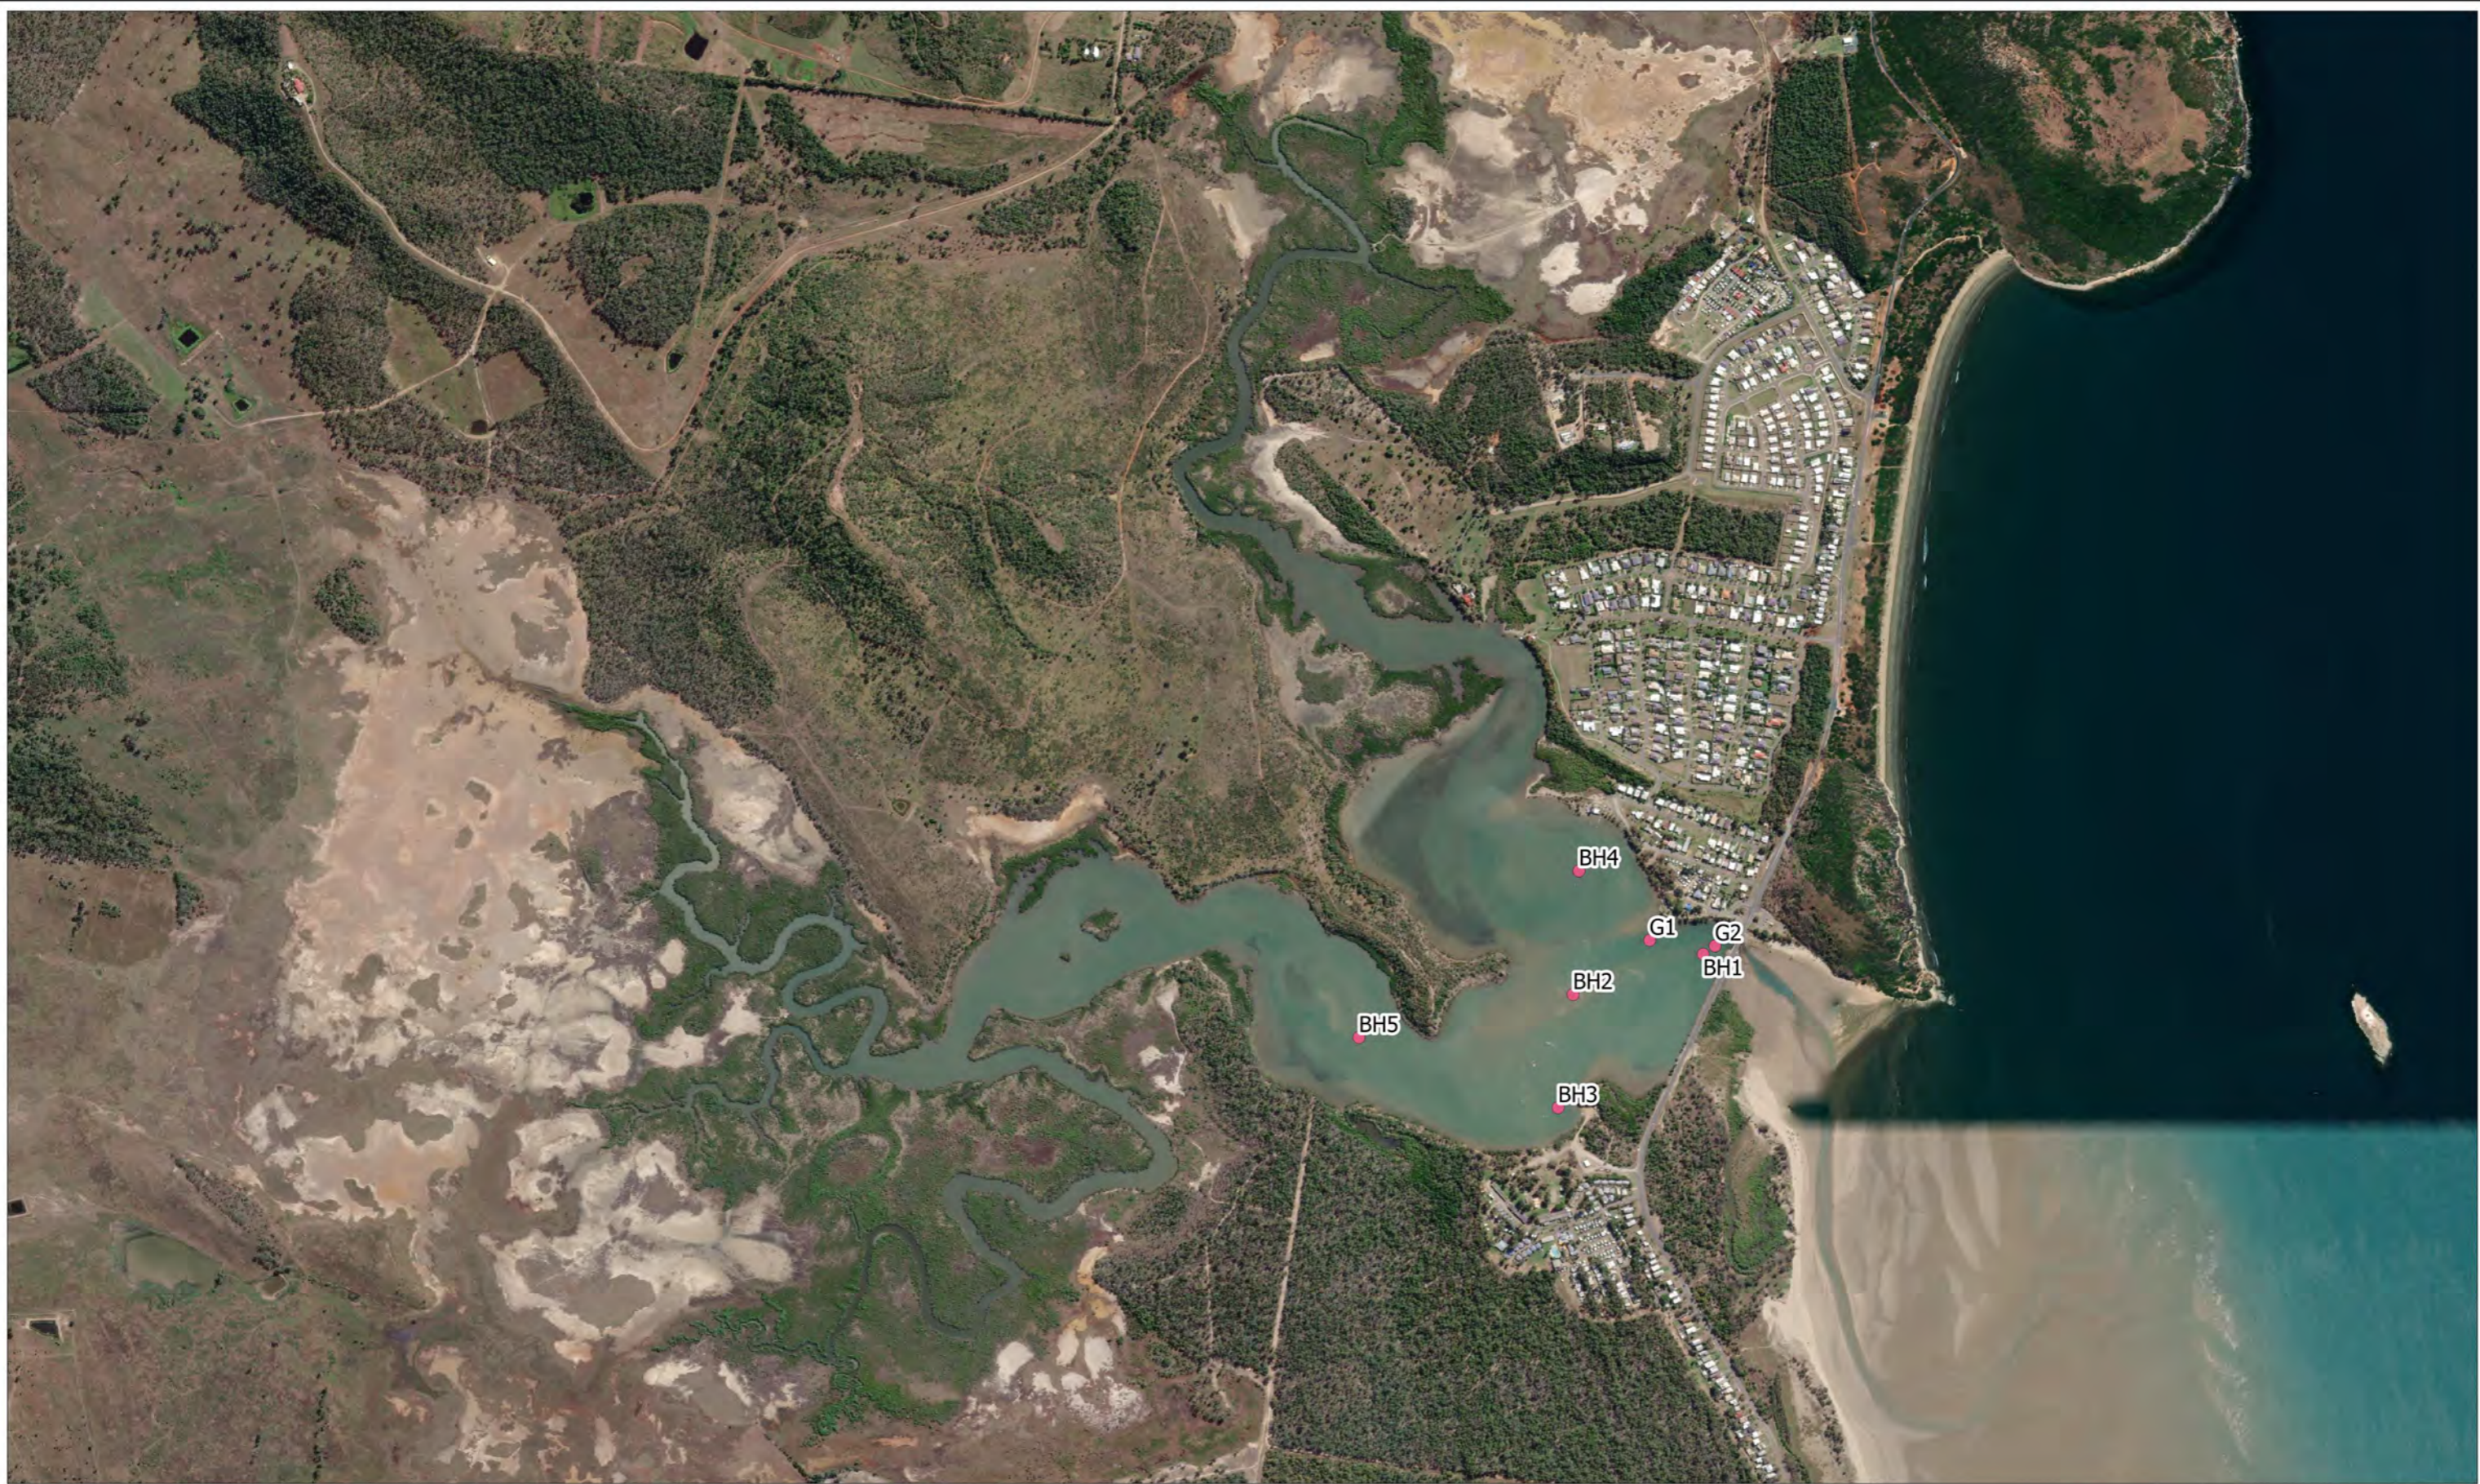
**Legend**

- Boreholes and surface grabs

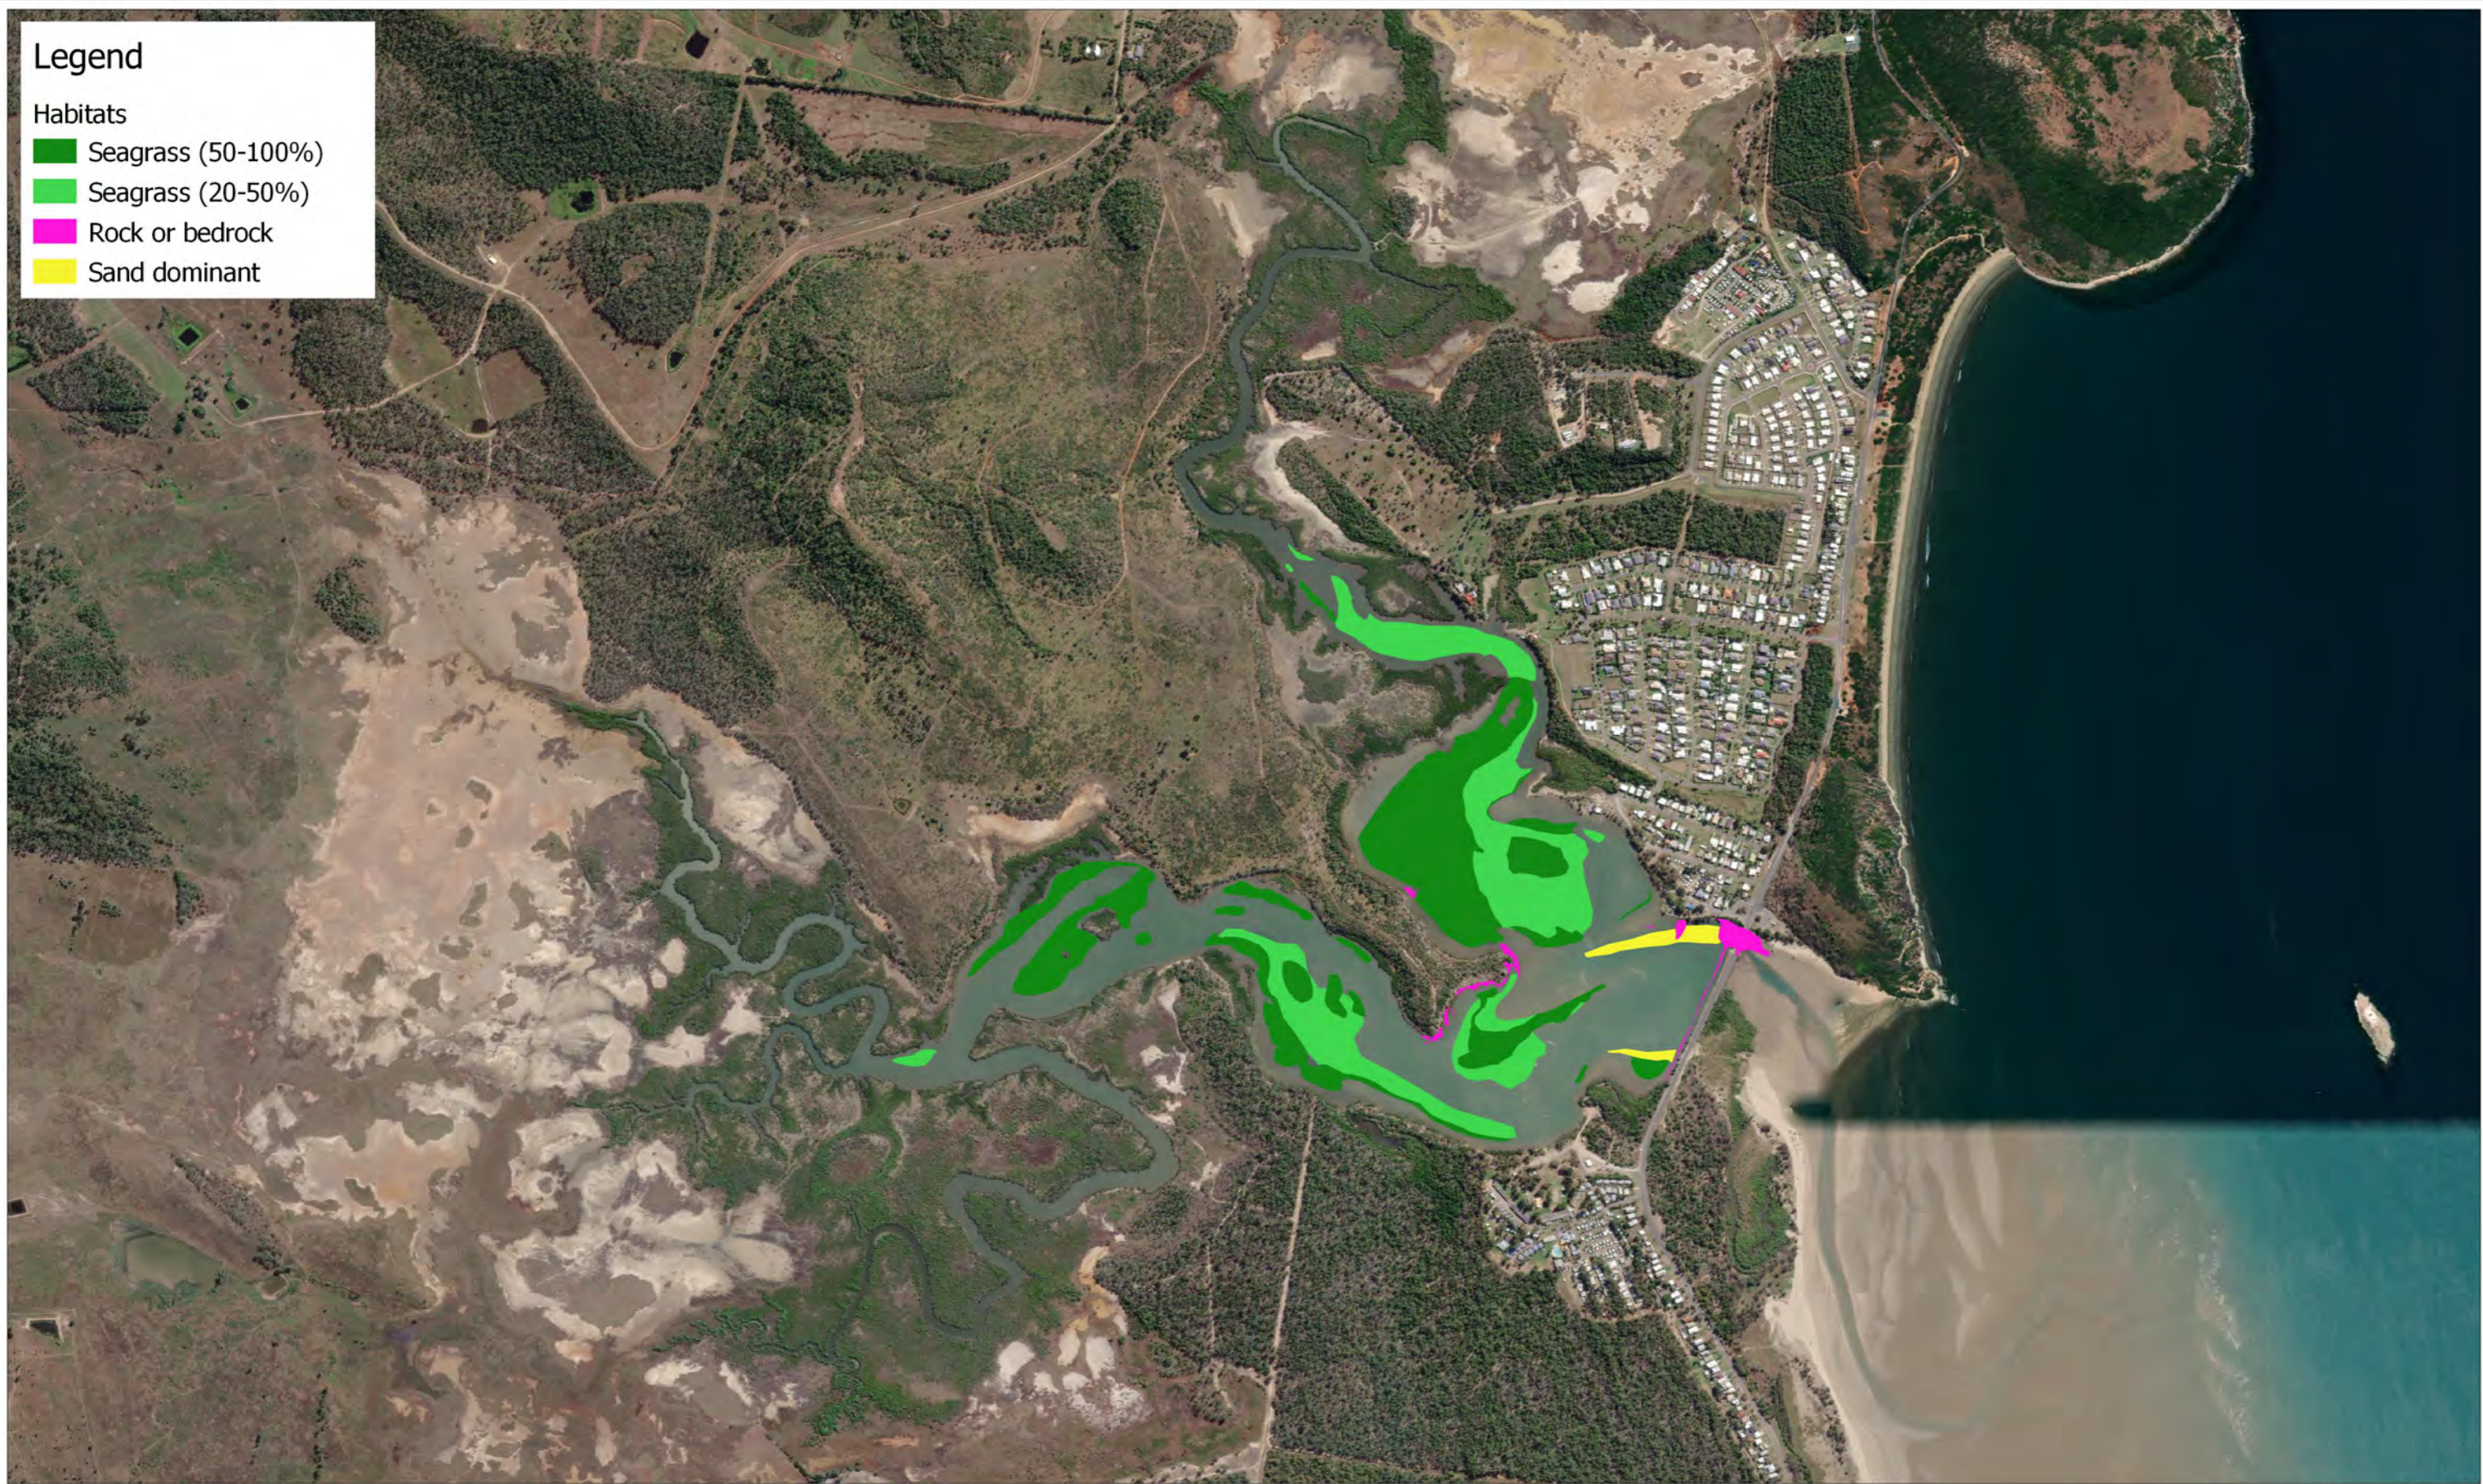
Figure:  
**3-5**

- Seagrass (50-100%)
- Seagrass (20-50%)
- Rock or bedrock
- Sand dominant

Title:  
**Benthic Habitats**

There was strong agreement between the areas of seagrass observable on aerial imagery, Sentinel-2, and on sidescan mosaics (Figure 3-4). Areas of dense (50-100%) seagrass cover and moderate to dense (20-50%) seagrass cover are shown in . It should be noted that low density seagrass (<5% cover) is likely to exist over a much larger area than the extent mapped in . This low density cover does not form meadows and was not observable from satellite or aerial imagery, nor did it appear to be consistent with regard to depth.

Rocky habitat was the other subtidal feature mapped in Causeway Lake. This was present surrounding the base of the causeway and rock wall, and at two other locations in the lake. There were no sensitive receptors (such as hard or soft corals) living on any of the rocky habitats. Epibenthic fauna consisted primarily of bivalves and sponges.

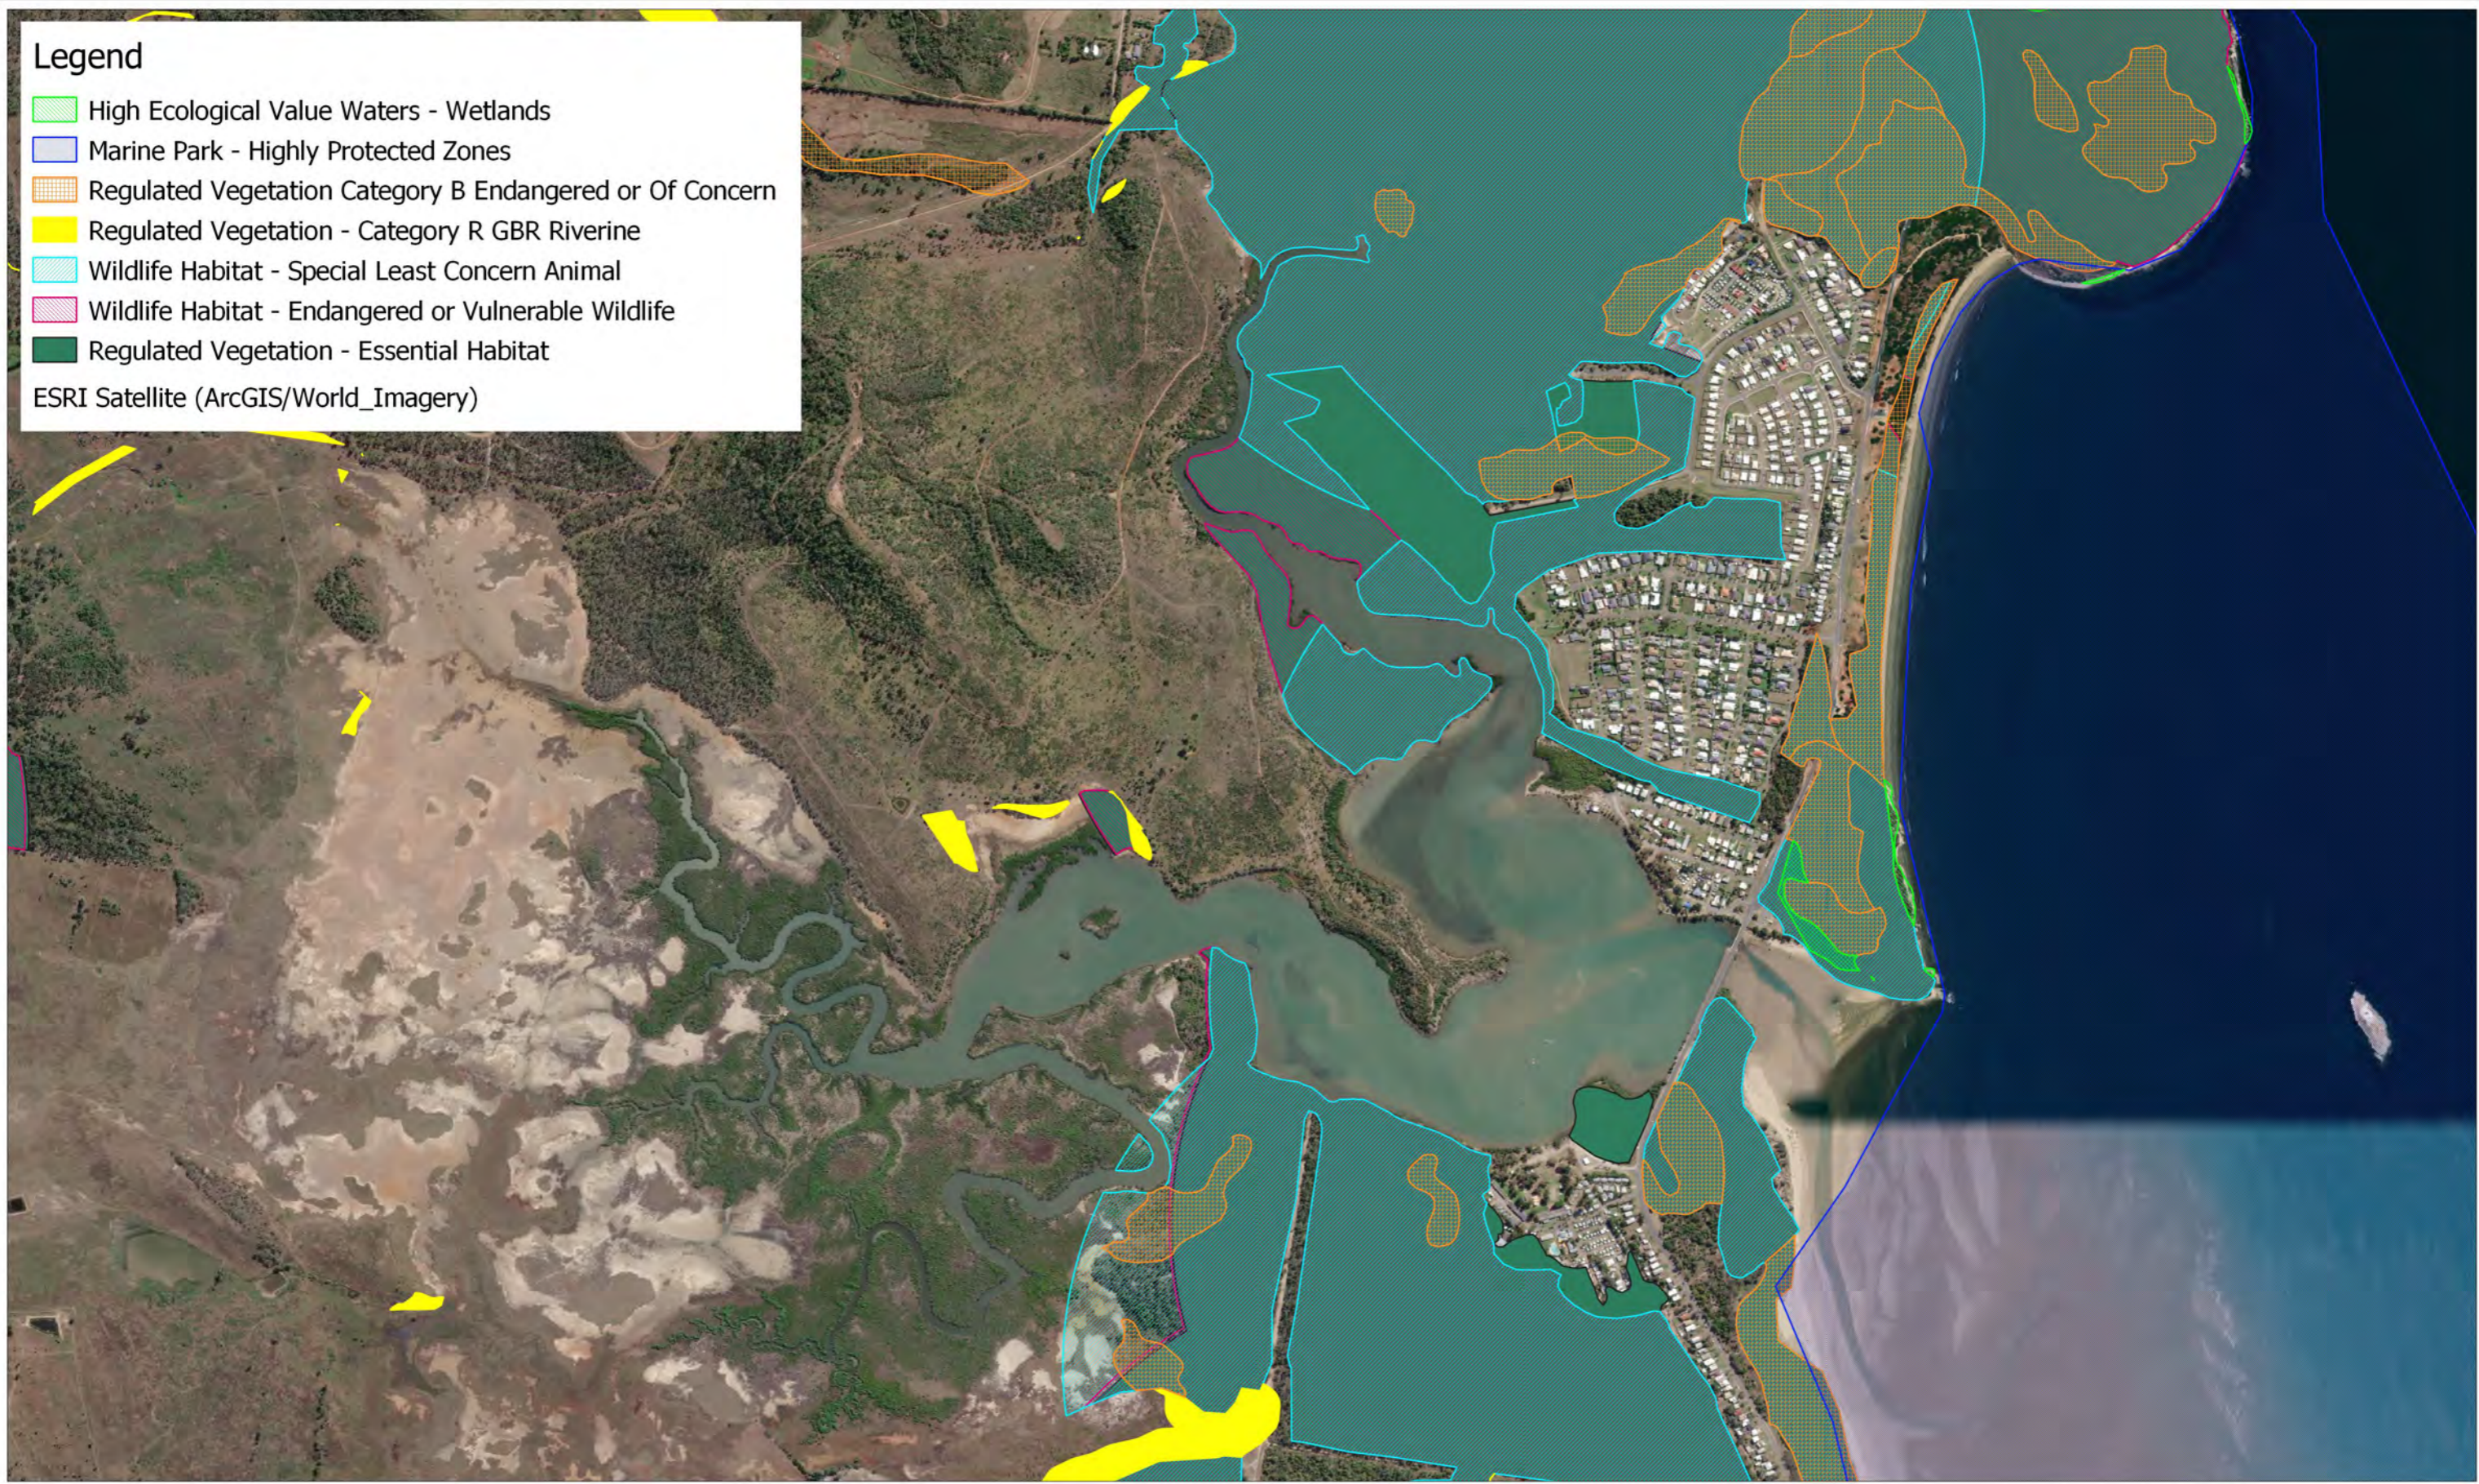
Figure: **2-2** Rev: **A**

- High Ecological Value Waters - Wetlands
- Marine Park - Highly Protected Zones
- Regulated Vegetation Category B Endangered or Of Concern
- Regulated Vegetation - Category R GBR Riverine
- Wildlife Habitat - Special Least Concern Animal
- Wildlife Habitat - Endangered or Vulnerable Wildlife
- Regulated Vegetation - Essential Habitat

Title: **Matters of State Environmental Significance**
